Environmental Conditions in San Martin Lake: Effects of Eutrophication in an Estuary Associated with the Laguna Madre

A Thesis

MASTER OF SCIENCE

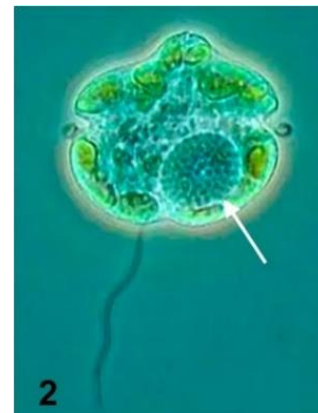
Figure 2: *Karenia brevis*: micrograph. Arrow indicates the nucleus. Photo courtesy of Florida Fish & Wildlife Conservation via Smithsonian Marine Station Commission http://www.sms.si.edu/irlspec/images/Kareni_brevis_2.jpg

2009; Hargraves, 2011). It typically has a nucleus in the lower left quadrant of the cell, (Figure 2), (Steidinger 2009; Vargo et al. 2009; Hargraves 2011).

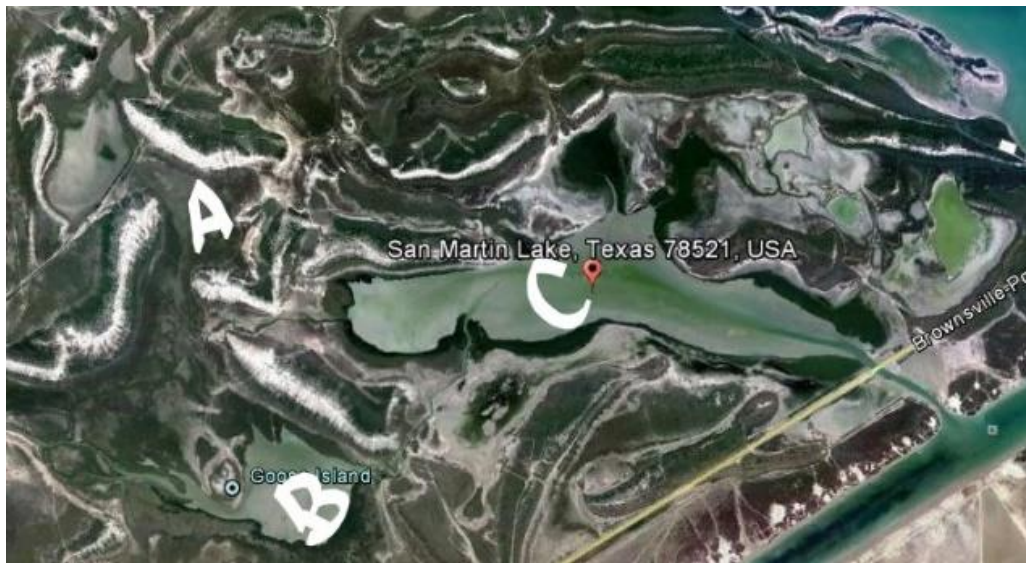
Figure 3: San Martin Lake: Source Google Earth Screen Capture. Three basins: A- primarily dry basin fills with heavy rains. B- shallow primarily freshwater basin. It is often heavily populated with wading birds, C- Primary site of research in this study which is the largest of the three basins and connected to the Brownsville Ship Channel by a channel on the east edge.

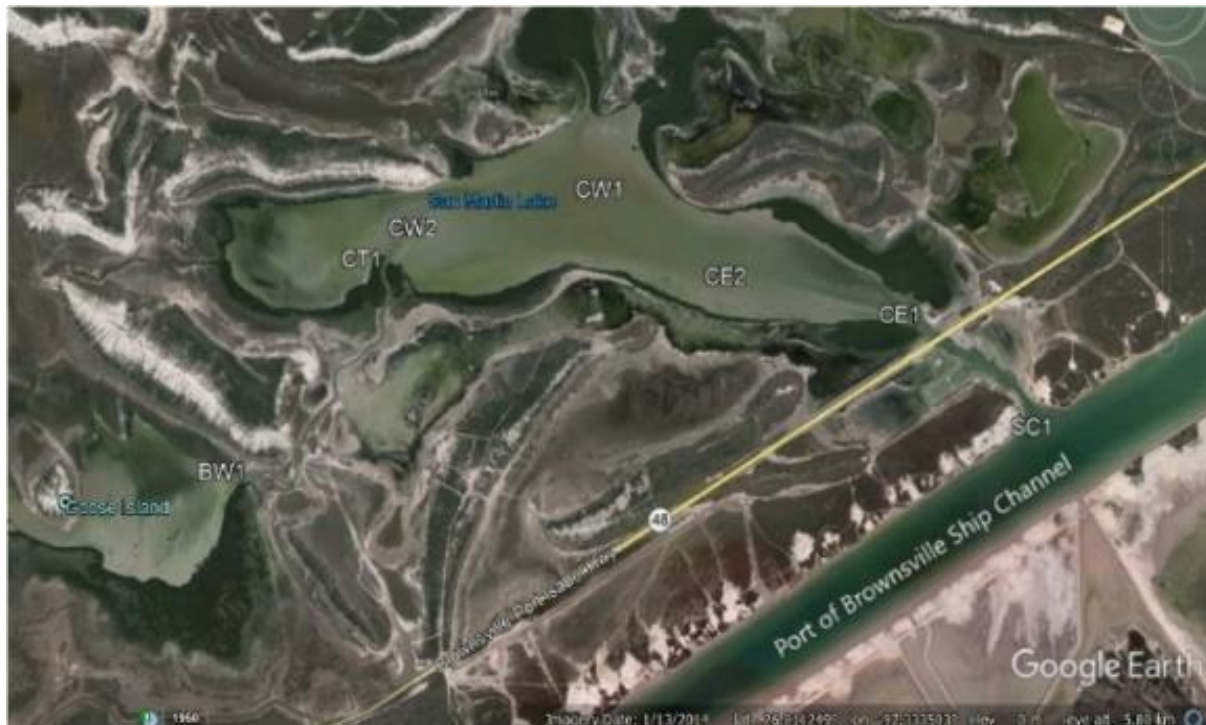
Figure 4: San Martin Lake sampling site locations. Source: Google Earth Screen capture or San Martin Lake and the Port of Brownsville Ship Channel. Site notations labeled by GPS coordinates using Google maps.

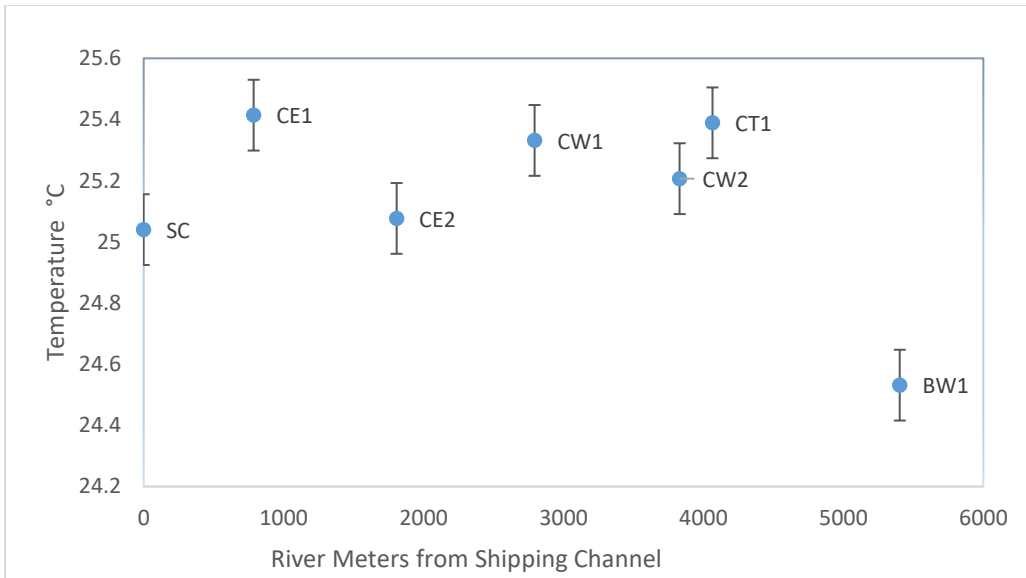
Figure 5: Water temperatures: Average temperature and ranges over one year. Distance is as the current would travel through the estuary.

The environmental conditions found in San Martin Lake were measured to help characterize the estuary. The following conditions were similar across the estuary with the variations that appeared to be changed consistently in association with weather patterns (See Appendix A). Water depth at the sampling locations ranged from <0.1m to >2.5m. with the sites more centrally located, near the boating channel, being the deepest. The depth of the estuary varies widely with the daily tides, with much of the area away from the boating lane being exposed at low tide. Water temperature ranged from 15°C in winter to 30°C in the summer months but also varied with the depth of the site(Figure 5). Dissolved oxygen was consistently high and ranged from 2.6 mg/L to 14.3mg/L. The basin was slightly alkaline with pH's ranging from 7.8 to 8.8. The turbidity was also consistently high ranging from 21 NTU to 323 NTU.

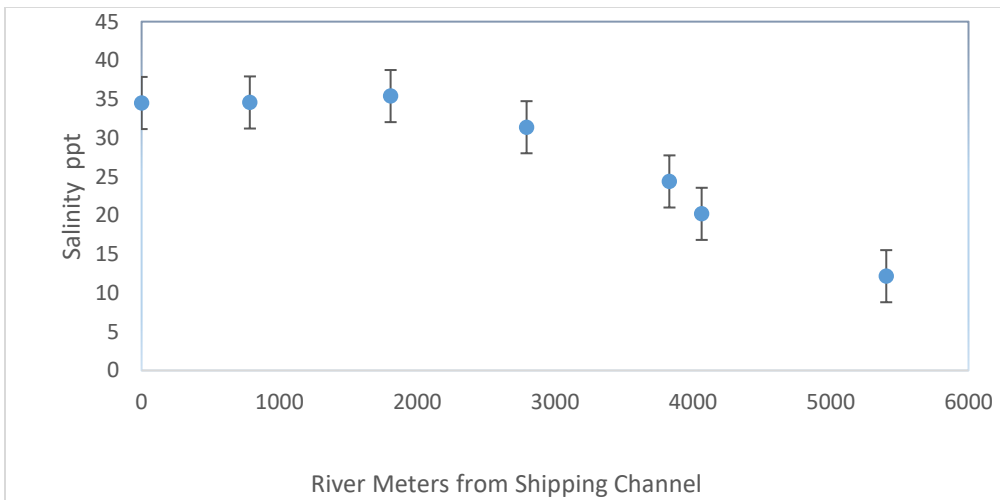
Figure 6: Salinity: Average salinity and ranges over one year. Distance is as the current would travel through the estuary.

Salinity was the one environmental condition to show a consistent spatial trend (Figure 6). As would be expected, the sites closest to the Brownsville shipping channel had the highest salinity ranging from 33.46 to 38.77, whereas the ship channel salinity ranged from 22.5 to 38.94. The salinity tended to be just slightly higher inside the cut to the east side of the lake than in the shipping channel suggesting some evaporative effect on the salinity. Equally predictable, the sampling locations farthest from the ship channel had the lowest salinities. The sampling site closest to the freshwater drainage source, site BW1, measured between 5.3 to 21.6, it was

usually slightly brackish, but at times was fresh. The sites between the two extremes were generally brackish.

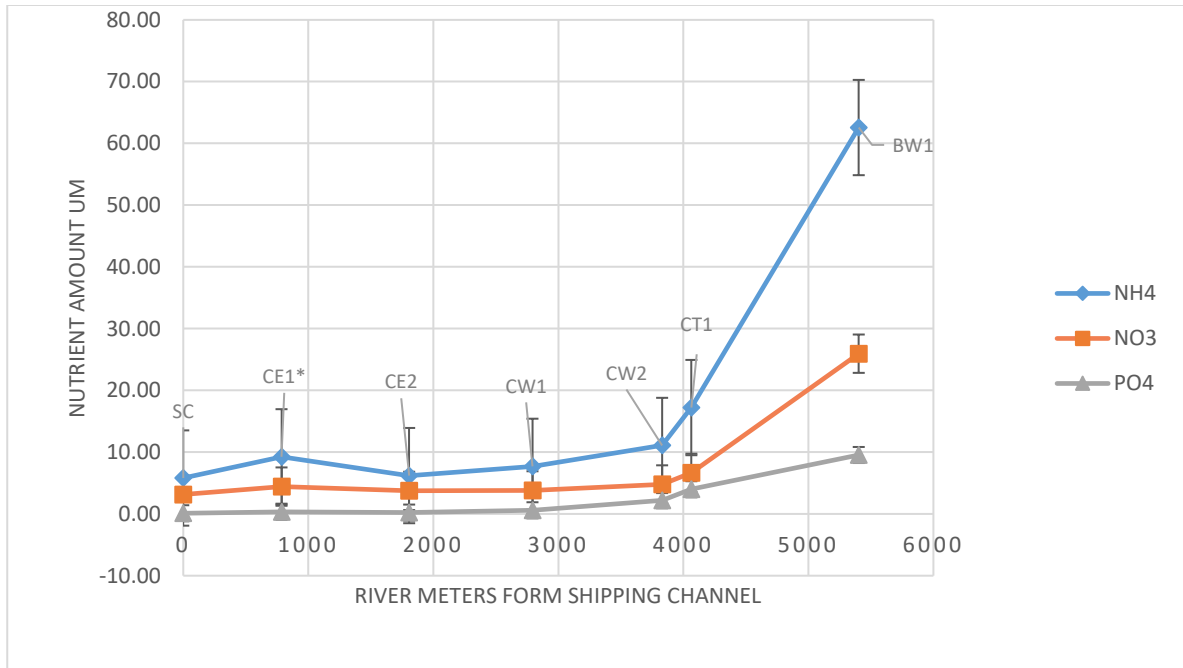
Figure 7: Nutrients: Average ammonia, nitrate-nitrite and phosphate levels in San Martin Lake. (micro-molar). Distance is as the current travels through the estuary * At CE1 has one data point omitted due to probable contamination.

The nutrients in San Martin Lake are highest in sites furthest the to the west and generally lowest nearest the ship channel to the east. Ammonia concentration for one sampling date at site CE1 was extremely high. It was omitted from the calculation of the average since it was suspected of being contaminated. Average nutrient levels at the exit of basin B, site BW1, were consistently high, $\text{NH}_4 = 62.5 \mu\text{M}$, $\text{NO}_3 = 25.9 \mu\text{M}$, and $\text{PO}_4 = 9.5 \mu\text{M}$. This would be the location closest to the drainage input to the estuary. At the ship channel site, nutrient levels were considerably lower likely due to dilution with averages being $\text{NH}_4 = 5.8 \mu\text{M}$, $\text{NO}_3 = 3.1 \mu\text{M}$, and $\text{PO}_4 = 0.11 \mu\text{M}$. Even though there is a drop in nutrient levels as water flows through the estuary, ammonia concentration remained high enough to support algal bloom initiation even at the exit of the estuary. Nitrogen is generally thought to be the limiting nutrient for algal blooms in marine systems. There were sufficient levels of nitrogen and phosphorous year-round to support algal blooms in basins C and in basin B. Evidence of green algal blooms were observed on several sampling dates in basin B as there were bright green algal mats floating in the water. This basin is difficult to access due to its shallow depth so was sampled at its exit into basin C, site BW1. It is likely that nutrient levels would be consistently higher in this location (Figure 7, Table 2).
