RESIDUAL SERVICE LIFE PROGNOSTIC MODELS
FOR TAPERED ROLLER BEARINGS

A Thesis

MASTER OF SCIENCE IN ENGINEERING

Major Subject: Mechanical Engineering

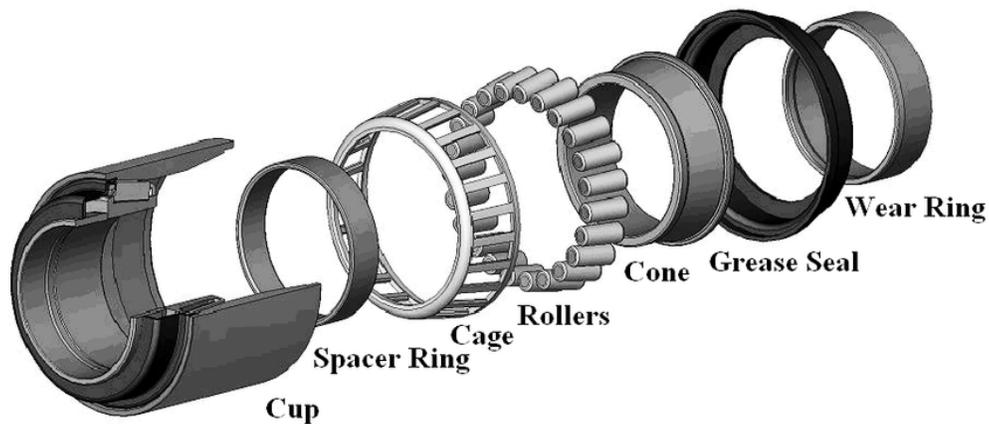
Figure 1. Components of a tapered roller bearing

The three primary components in a tapered roller bearing are the outer ring (cup), inner ring (cone) and rollers. The outer ring houses two inner rings. Each inner ring is surrounded by

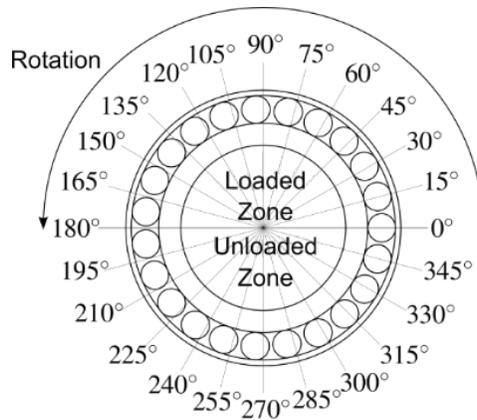
The bearing outer ring (cup) is held stationary by the railcar load applied through the side frame. This creates a top loaded scenario as the one depicted in Figure 2. With the cup as a static element, it will experience constant forces as the movement-restricting loads are placed upon it. The cones, however, are able to rotate freely inside the cup, prompting this component to cycle in and out of the loaded zone. This cyclic loading results in the cone seeing smaller stresses and consequently less wear than that observed in the bearing cup. The rollers both rotate and revolve around the cone and thus see the least stress. These motions and varying load behaviors lead to the components having different spalling rates and defect development probabilities.

Figure 2. Schematic showing direction of rotation relative to loaded and unloaded zones

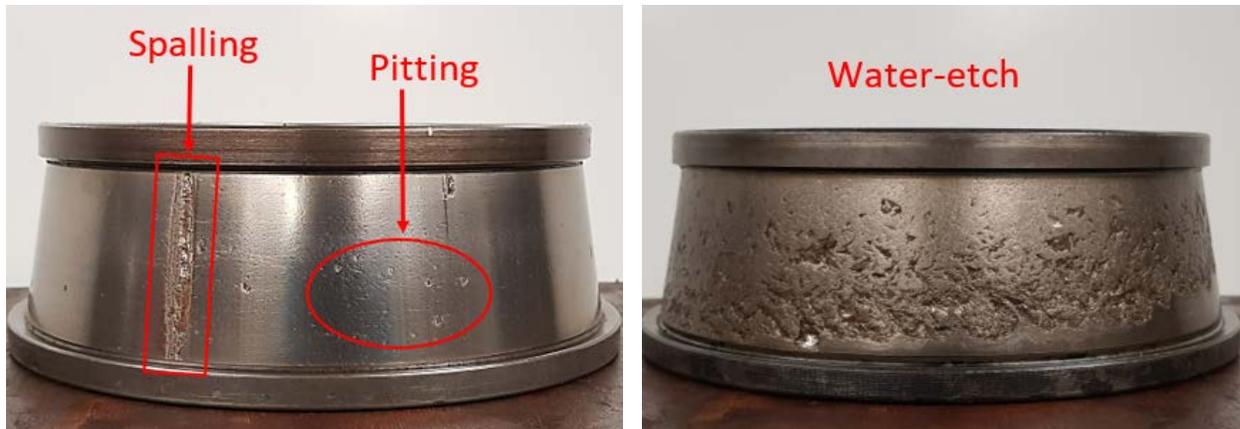
Bearing defects are categorized into three principle classifications: geometric, distributed, and localized. Geometric defects are caused by intolerances in the bearing geometry due to manufacturing errors. These defects are prone to causing high operation temperatures in a bearing without any visible signs of a surface flaw. A bearing is considered to have a distributed defect when a component has multiple imperfections along a raceway or when several components of the same bearing have developed a defect. An example of a distributed defect is shown in the water-etch inner ring in Figure 3 (right). Water-etch defects are caused by moisture entering the bearing, likely due to faulty seals. Once water enters, it commences a process of grease degradation which compromises the frictionless rotation common to a bearing and causes a sped abrasion rate in the components. Localized defects can be subcategorized into cracks, pits and spalls. Examples of spalling and pitting can be seen in Figure 3 (left).

Figure 3. Example of localized defects (left) and distributed defect (right)

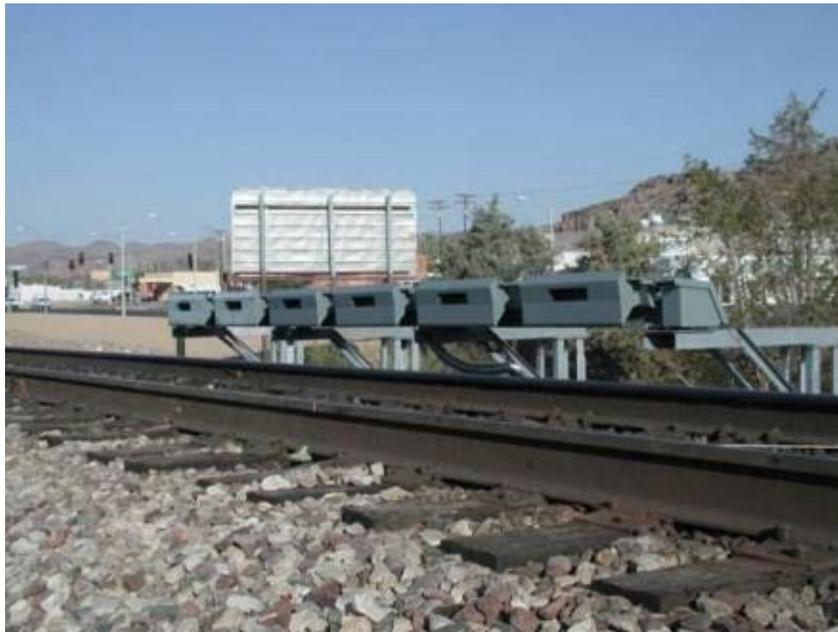
The Transportation Technology Center Inc. (TTCI) developed TADSTM™ to monitor bearing health through acoustic signatures. TADS™ utilizes microphones to detect severe, high-risk defects in bearings as the train passes through the wayside system. These high-risk defects are termed “growlers” due to the low frequency the large spalled area (over 90% of the component raceway) produces. This system is an example of a reactive wayside detector, as it specializes in diagnosing end-of-life bearings. While TADS™ has a high proficiency in recognizing end-of-life bearings, not all severe defects are detectable through their algorithm and small or initiating defects will not be perceived [5]. As of March 2017, only 19 TADS™ are in operation nationwide, meaning that many freight cars can go through their entire service life without encountering one of these systems [6].

Figure 4. Photograph of a TADS™ site[6]

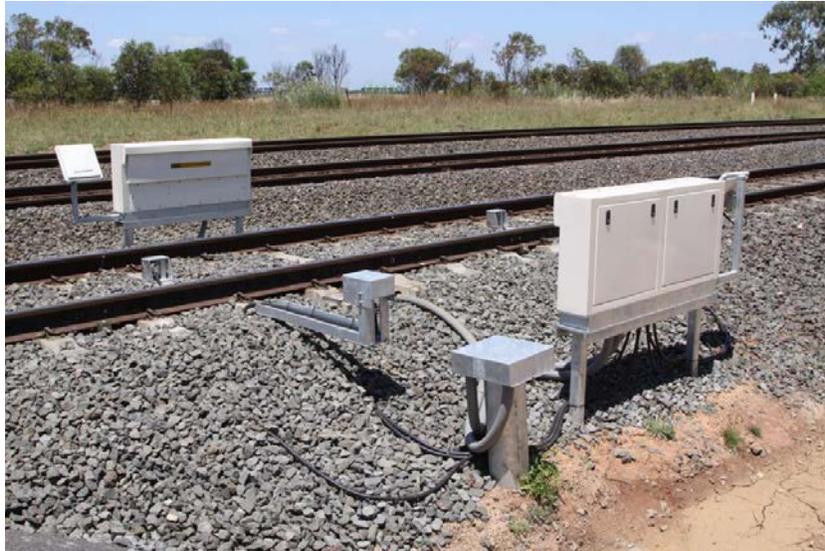
RailBAM®, shown in Figure 5, can process 200 wagons passing through the system at speeds greater than 50 km/h (30 mph) in less than 10 minutes [7]. Native to southern Australia, only 20 RailBAM® detectors are in operation, causing the same predicament as TADS™ of neglecting railcars not passing through the system's routes [6].

Figure 5. Photograph of a RailBAM® system

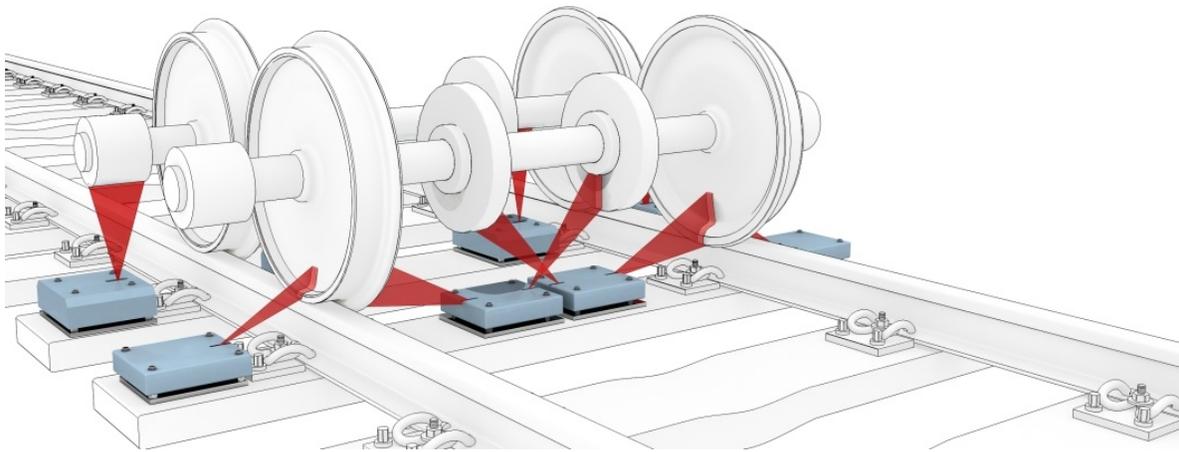
Hot-Box Detectors (HBDs) work through a series of infrared sensors that scan bearings, wheels, and brakes as the rail cars pass over the detectors, as shown in Figure 6. If the operating bearing temperatures obtained through the HBD are greater than 76.7°C (138.06°F) above ambient or greater than 35°C (65°F) above the temperature of the bearing that shares the same axle, the train operator will be alerted. HBDs are placed approximately 40 km (25 miles) apart along the track. Over 6,000 detectors can be found across North American railroads, making these detectors the most common form of wayside condition monitoring system in the U.S. Even with the abundance of HBDs, there are still major problems encountered while analyzing this system.

Figure 6. Example of a Hot-Box-Detector (HBD) site[8]

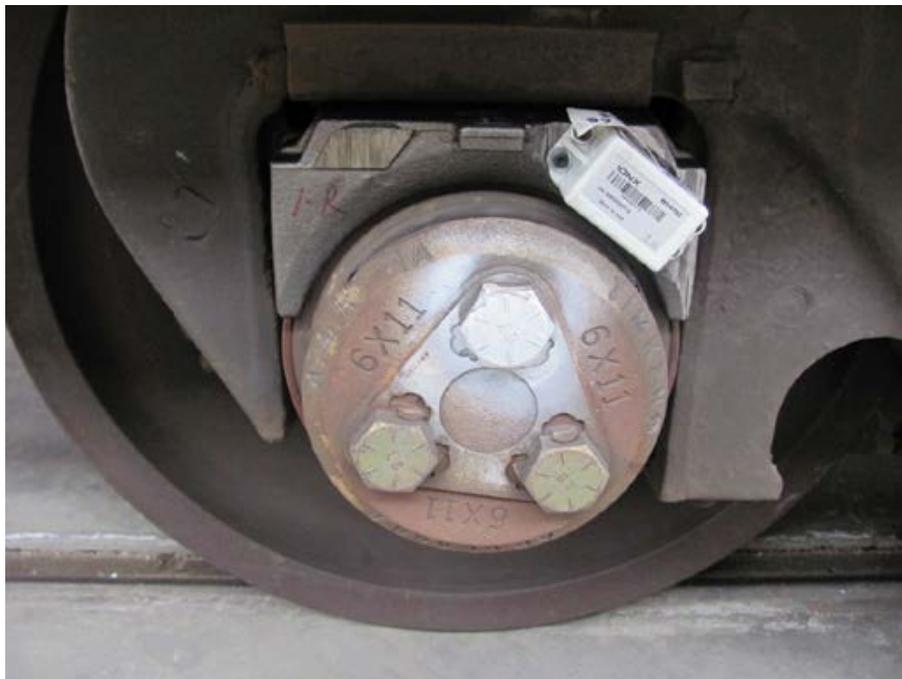
Wireless sensor nodes (WSN), such as the one developed by IONX shown in Figure 7, provide continuous real-time bearing temperature data to the locomotive engineer. WSNs contain Central Monitoring Units (CMU) which record both the bearing and the current ambient temperature [14]. WSNs use various algorithms to create a trend analysis of the bearing temperatures and provide early warning of possible failure. The CMU transmits this data via satellite or cellular network to the engineer for warranted action.

Figure 7. Field installation of a Wireless Sensor Node

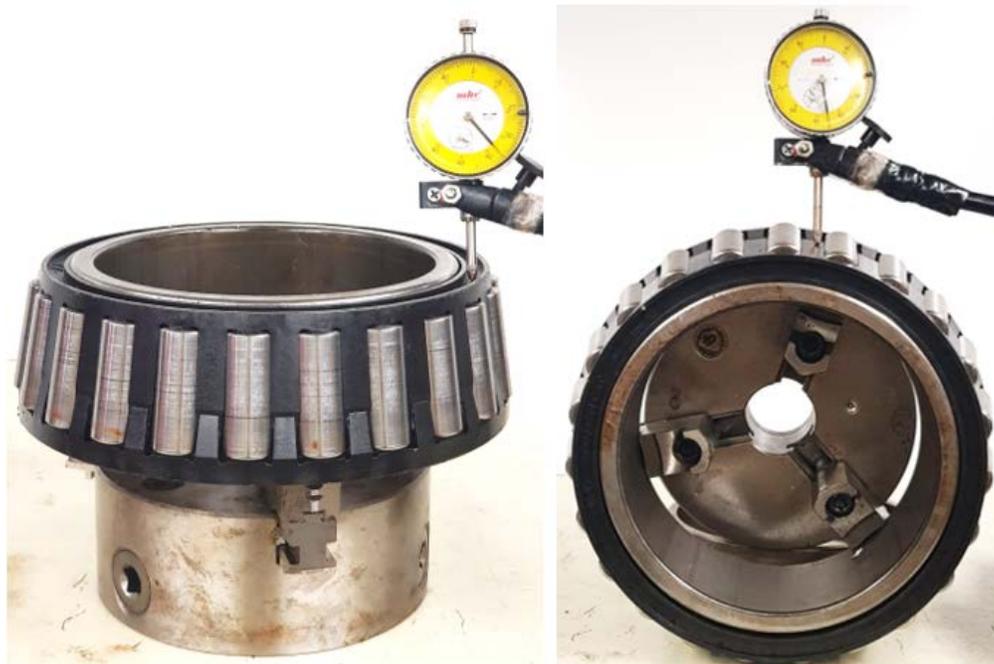
Every inner ring (cone) selected requires cage lift, cage shake, and roller spacing measurements to be taken. Cage shake and cage lift are performed with a dial indicator and serve to measure the lateral and vertical motions of the roller cage with respect to the cone. A setup of these measurements can be observed in Figure 8. Roller spacing measurements are carried out by inserting a feeler gauge in the space between the roller and the cage rib. These measurements are used to minimize the possibility of roller skew (misalignment) due to abnormal spacing in the cages holding the rollers against the inner ring. Maximum and minimum lateral measurements of the bearing assembly are also taken with a desired range of 0.023in to 0.028 in. Laterals help determine if the correct spacer ring has been selected. The spacer ring helps keep the bearings spinning parallel to the axle. Otherwise, like the rollers, the bearings might roll skewed, preventing optimum rolling speeds.

Figure 8. Cage measurement set-up: cage lift (left), cage shake (right)

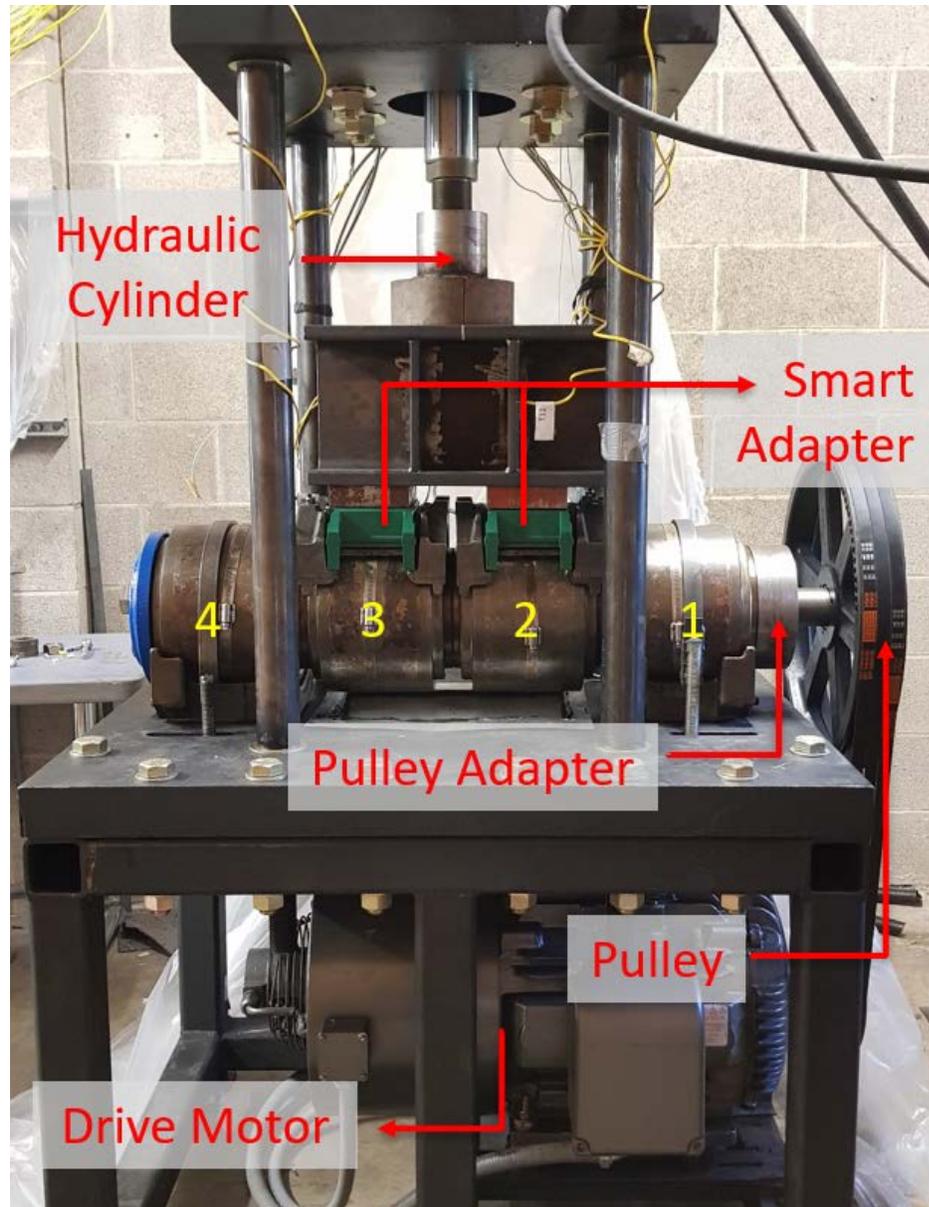
Figure 9. Four-Bearing Tester (4BT)

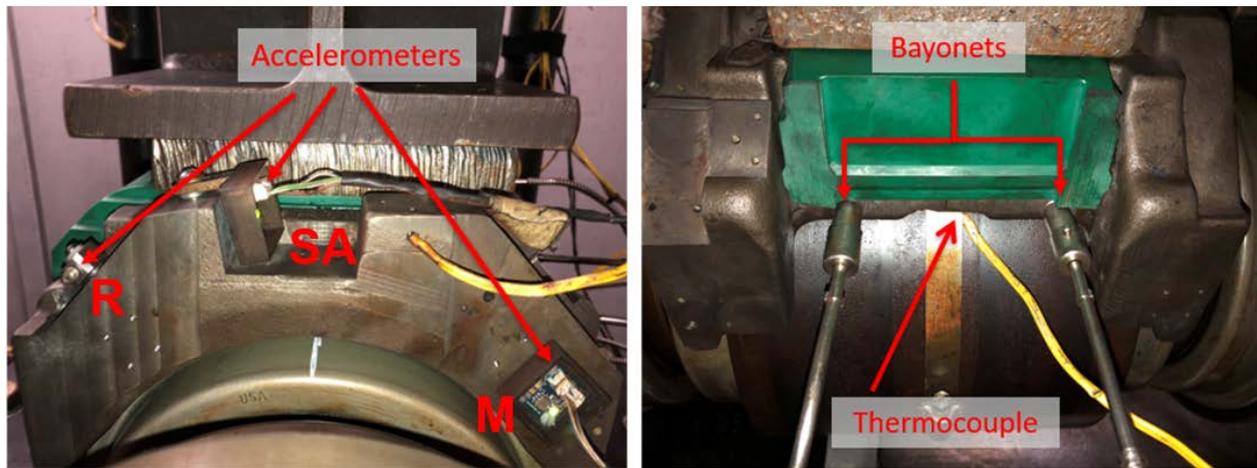
For this study, it was necessary to track and record the temperature and vibration signatures of the test bearings. To do so, the steel adapters were machined to accept two 70g accelerometers placed in the outboard SmartAdapter™ (SA) and mote (M) locations, along with one 500g accelerometer placed in the outboard radial (R) location. To monitor the bearing operational temperature, the adapter was outfitted with two bayonet thermocouples placed in the middle of each raceway, and one regular K-type thermocouple that was held tightly against the

middle of the outer ring (cup)utilizing a hose clamp. The modified adapter displaying the accelerometer (right) and thermocouple (left) locations is pictured in Figure 10.

Figure 10. Modified 4BT adapter showing vibration sensors (left) and temperature sensors (right)

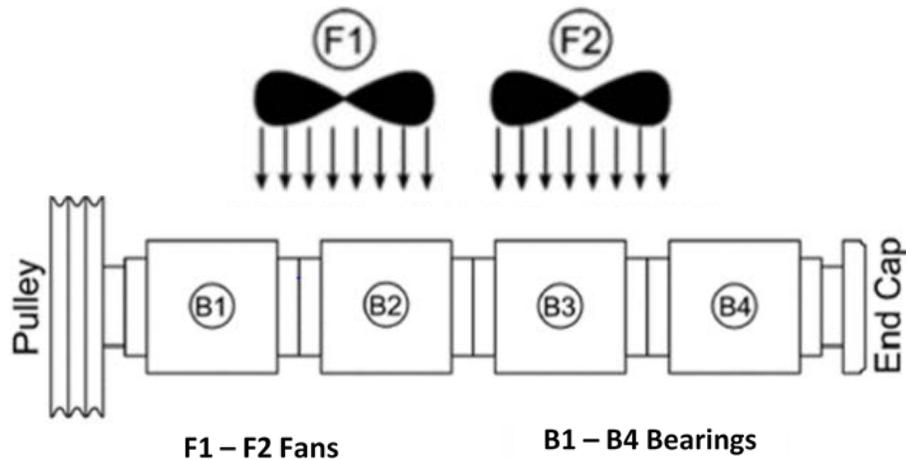
Figure 11. Top view of four-bearing tester (4BT)

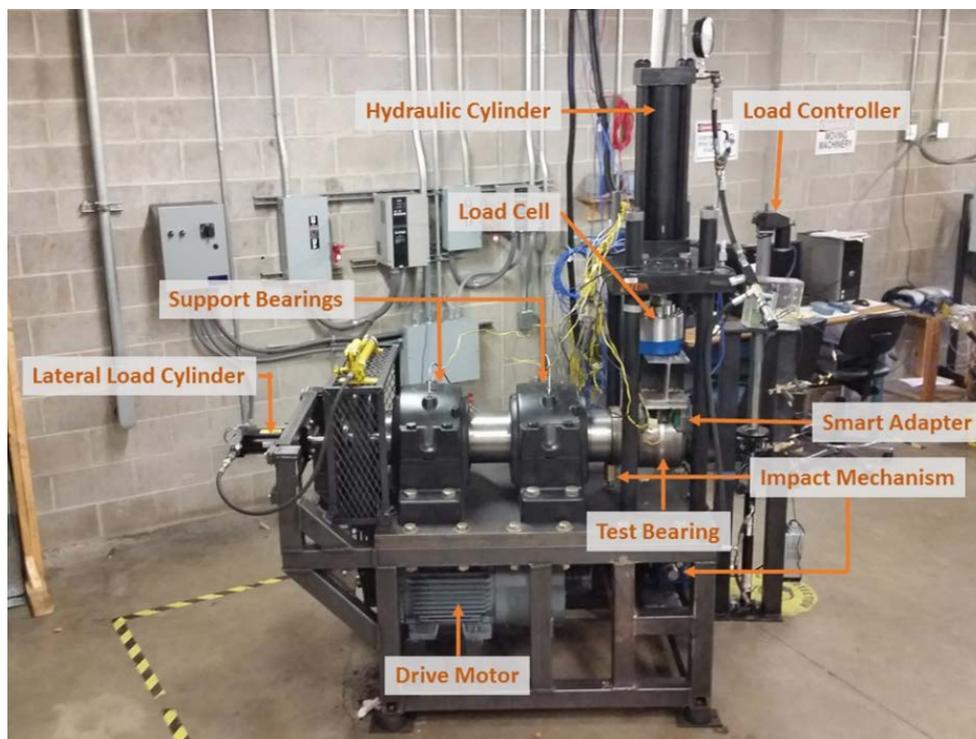
Aside from two industrial size fans supplying convective cooling, as those used on the four-bearing tester, the SBT employs a specially designed cooling system fabricated by the UTCRS research team. The setup allows for chilled water to run over the pillow blocks which house the support bearings. The purpose of incorporating this system is to prevent the tester's support bearings from overheating during an experiment.

Figure 12. Single bearing tester (SBT)

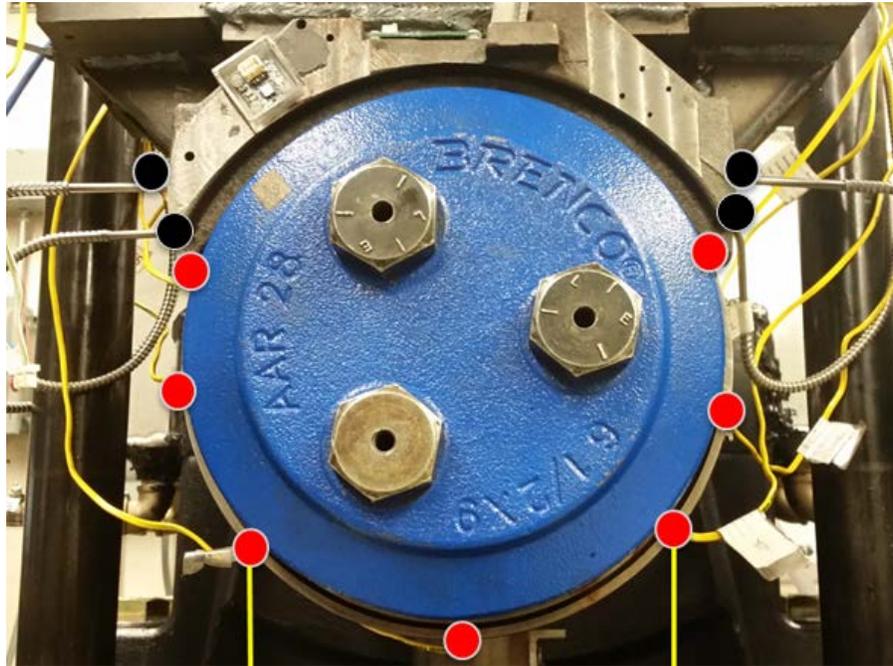
Additionally, seven K-type thermocouples were held via a hose clamp around the circumference of the bearing. The bearing thermocouple locations are shown in Figure 13.

Figure 13. Single bearing tester thermocouple locations: bayonets represented by black dots, K-type thermocouples represented by red dots

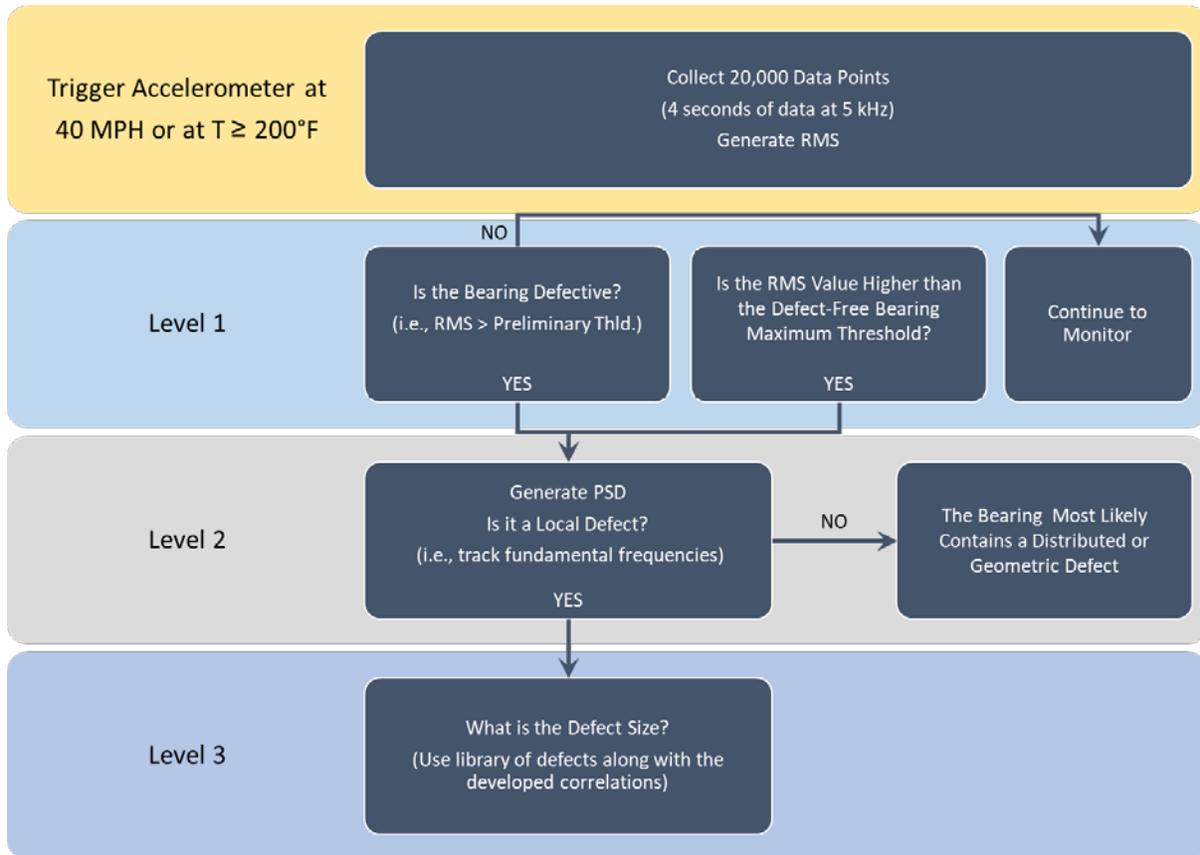
The defect detection algorithm developed by Gonzalez [16] can detect, with 95% accuracy, the onset and propagation of tapered-roller bearing raceway defects. The algorithm is activated when operating speeds are above 65 km/h (40 mph) or when the bearing's operating temperature surpasses 93°C (200°F). Once the accelerometer is triggered, the algorithm will go through three levels of analysis to provide information pertaining to the bearing condition including the presence of any spalls (defects), defect classification, and approximate defect size.

Figure 14. Defect detection algorithm flowchart [16]

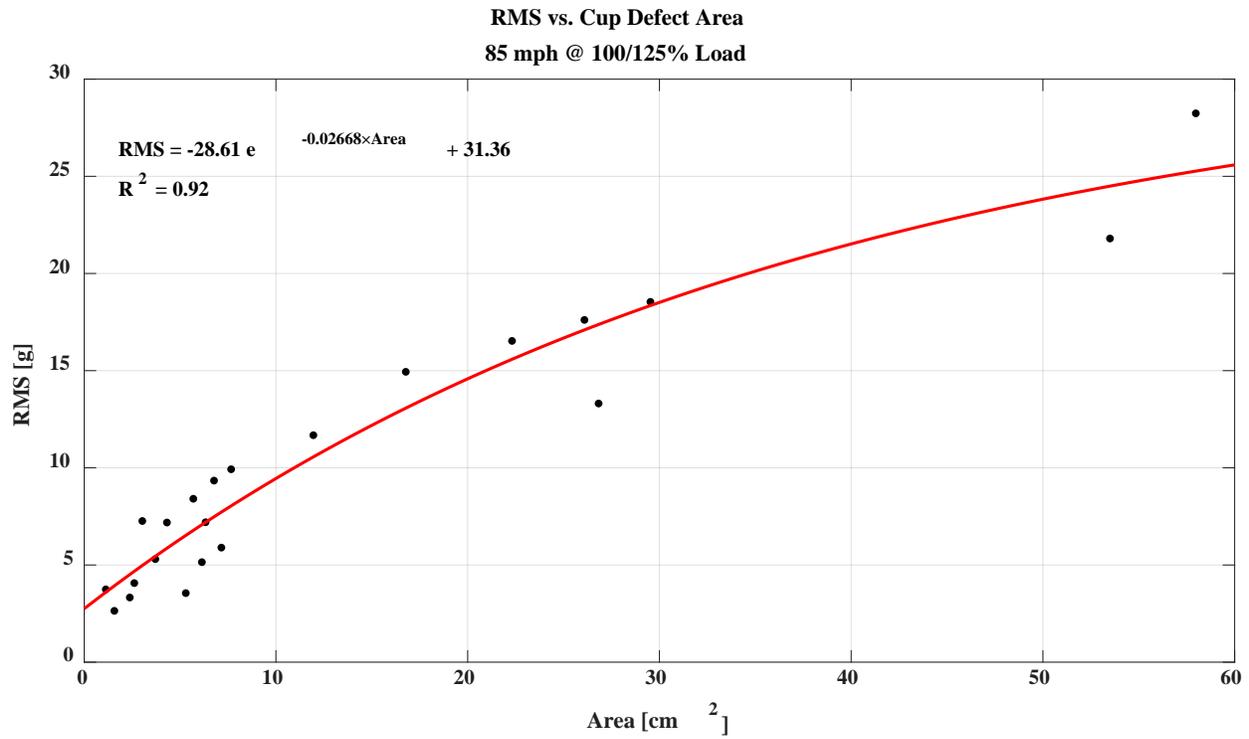
Level 3 analysis provides an estimate of the localized defect area(size) for the defective bearing component identified in Level 2 analysis. Level 3 analysis relies on previously developed vibration data correlations to obtain good estimates (generally within 10%) of the defect area. The defect size correlations for the outer ring (cup) and inner ring (cone) produced by Gonzales are shown in Figure 15 and Figure 16, respectively. These defect size correlations were later enhanced by Montalvo [17]. A correlation for the rollers was not developed due to the infrequency with which a roller defect occurs in rail service unaided by the spalling of its surrounding components.

Figure 15. RMS - Cup defect size correlation at 137 km/h (85 mph) and full load[16]

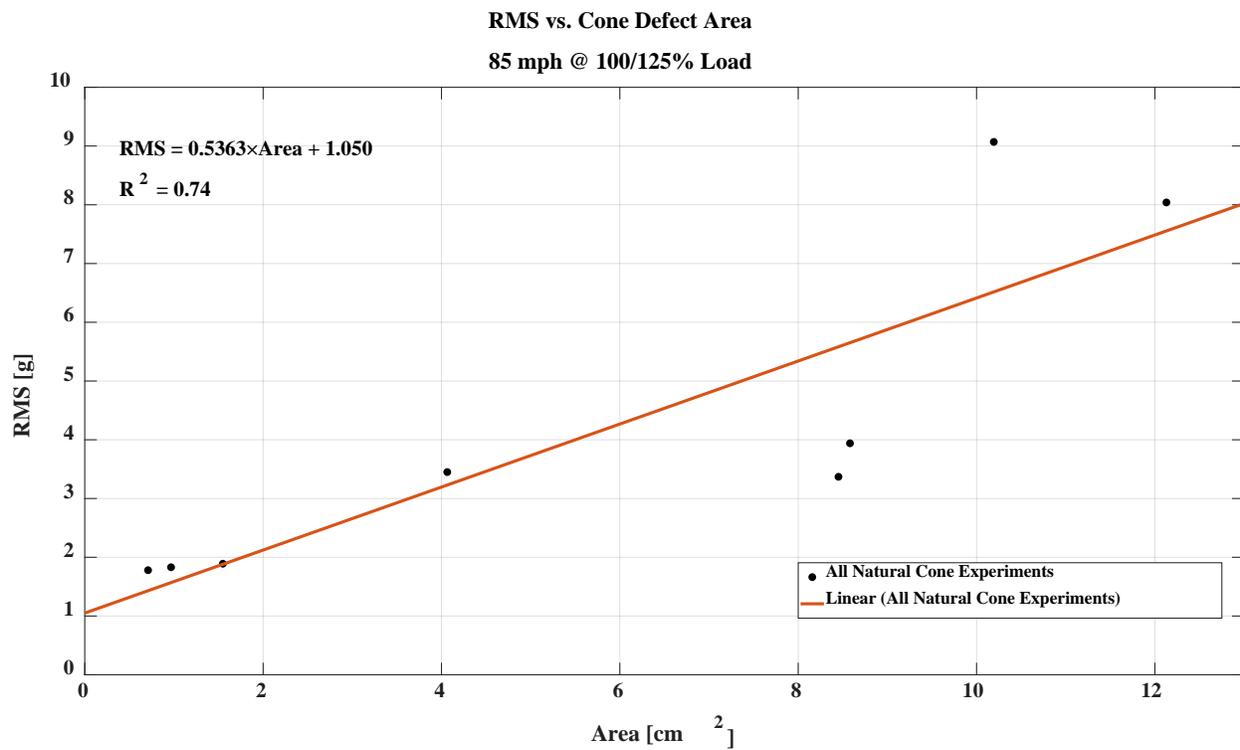
Figure 16. RMS - Cone defect size correlation at 137 km/h (85 mph) and full load[16]

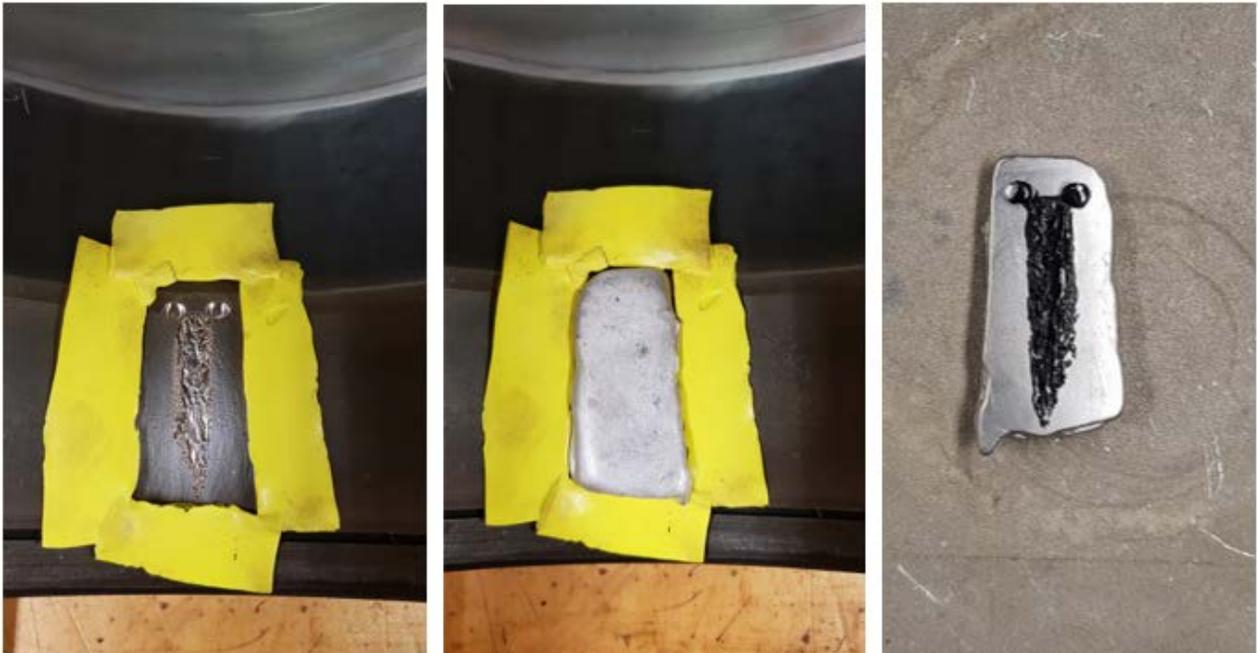
Once the vibration monitoring algorithm alerts of signatures above the threshold for a healthy bearing, the experiment is stopped, the bearing is disassembled, and each component is visually inspected. If a defect has developed or a spall has propagated, the area is cleaned thoroughly and surrounded with sealant tape (capable of withstanding a maximum temperature of 204°C or 400°F). After the sealant tape creates a mold around the defect area, a molten bismuth alloy with a melting temperature of 80°C (176°F) is poured into the sealant tape frame enclosing the spall. The casting process is depicted in Figure 17. These casts help keep a reliable record of the spall areas and their progression when the bearing is reassembled and pressed onto the test axle for further defect propagation.

Figure 17. Casting procedure using sealant and bismuth tape

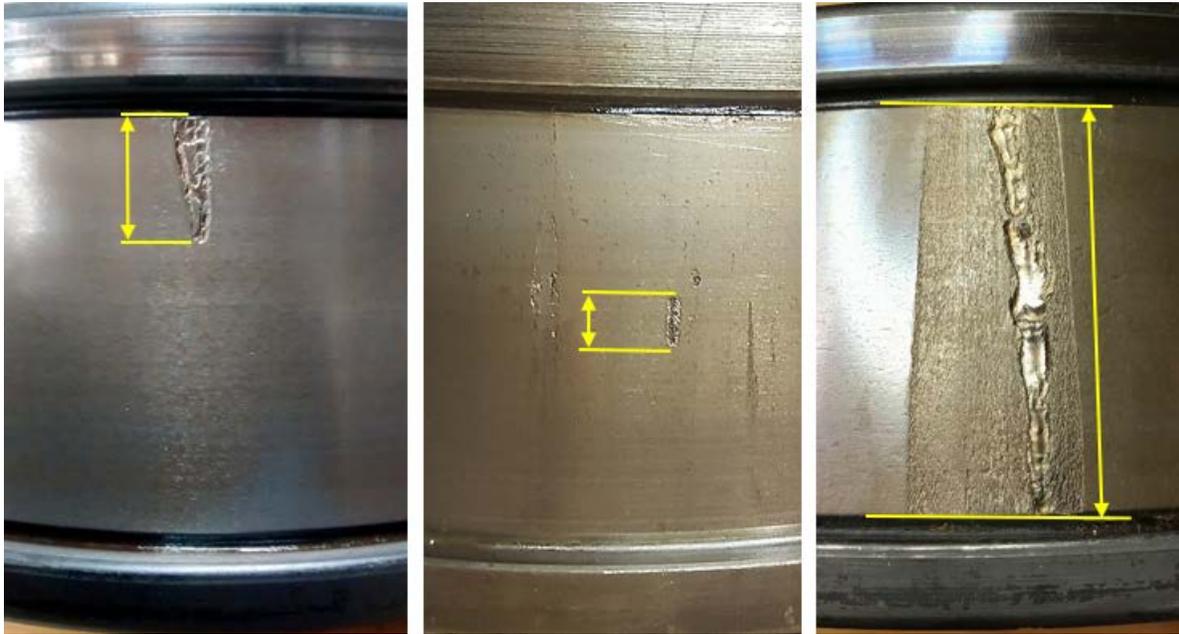
width spall in Figure 18 (right). Once the edges are reached, the spall will expand circumferentially along the component raceway.

Figure 18. Spall regions depicted in inner rings: edge (left), center (center), full-width (right)

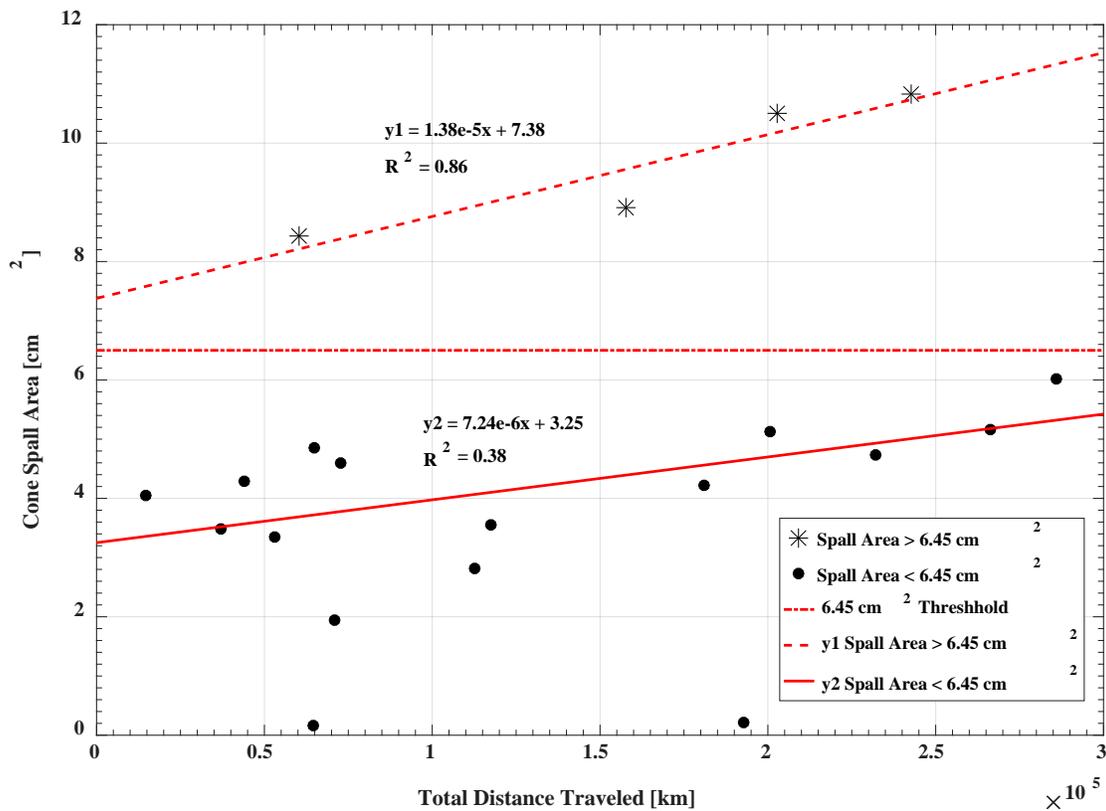
the transition is approximately 6.5 cm² (approximately 1 in²) Findings demonstrate that cone spalls with areas larger than the threshold will grow faster than those below the threshold [20]. In addition to the accelerated deterioration, the mechanisms of growth for larger spall areas displays less variation ($R^2=0.86$) in growth-rates than is seen in spall areas below the threshold which show higher variation in growth rate and a poorer match to the linear fit ($R^2=0.38$).

Figure 19. Cone spall size vs total distance traveled [20]

In spite of the inner ring (cone) and outer ring (cup) having similar spall growth trends, the primary difference observed between Figure 19 and Figure 20 is the threshold area. This variation in the threshold area for these two models is attributed to the roller contact area in the components [20]. The cone, a convex surface to the roller, will experience approximately 10% smaller contact areas than the concave surface provided by the outer ring (cup) raceway. A visual representation of these geometries is provided in Figure 21. When calculating the Hertzian contact stress, a smaller contact area yields a larger depth of max shear stress as well as 10% higher maximum Hertzian contact stresses **Error! Reference source not found.**

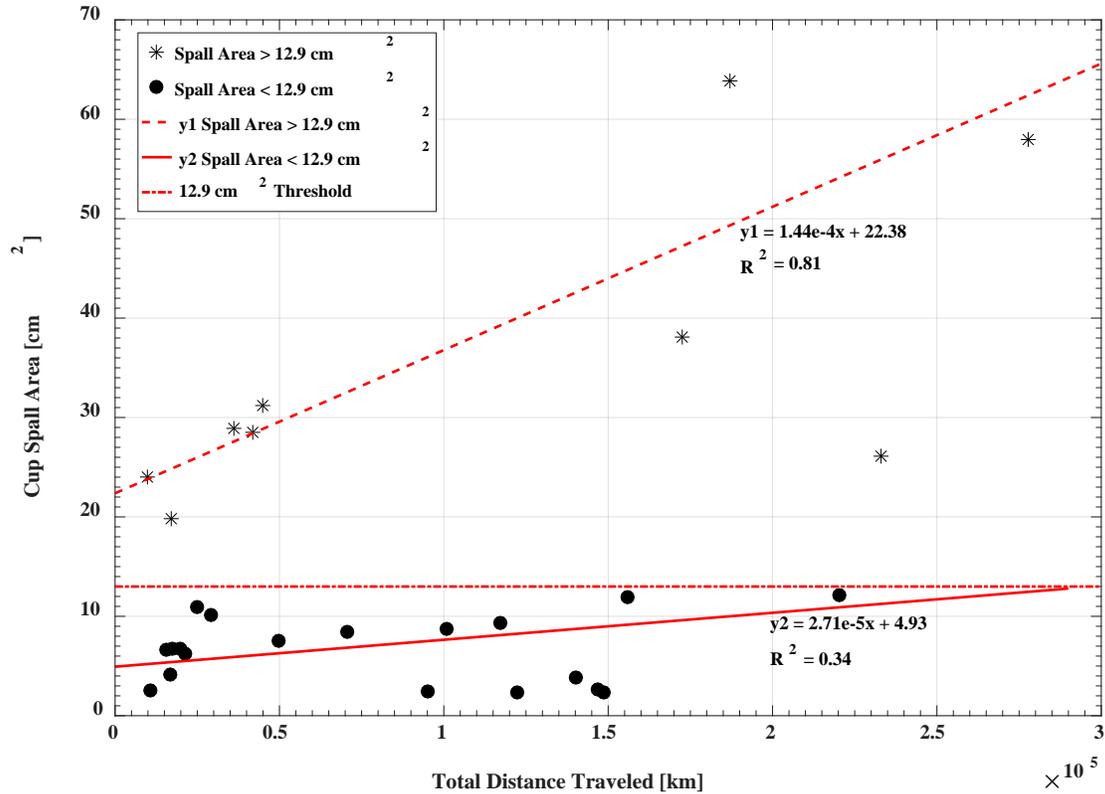
experienced by larger spalls will increase the subsurface shear stress which may lead to faster growth rates.

Figure 20. Cup spall size vs distance traveled [20]

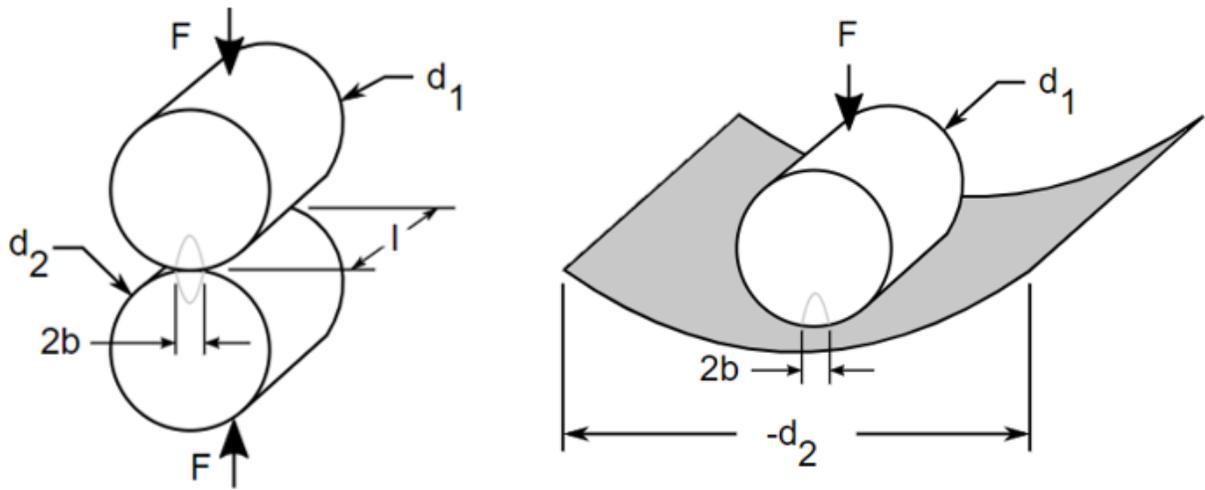
Figure 21. Contact area models: convex inner ring (left), concave outer ring (right)

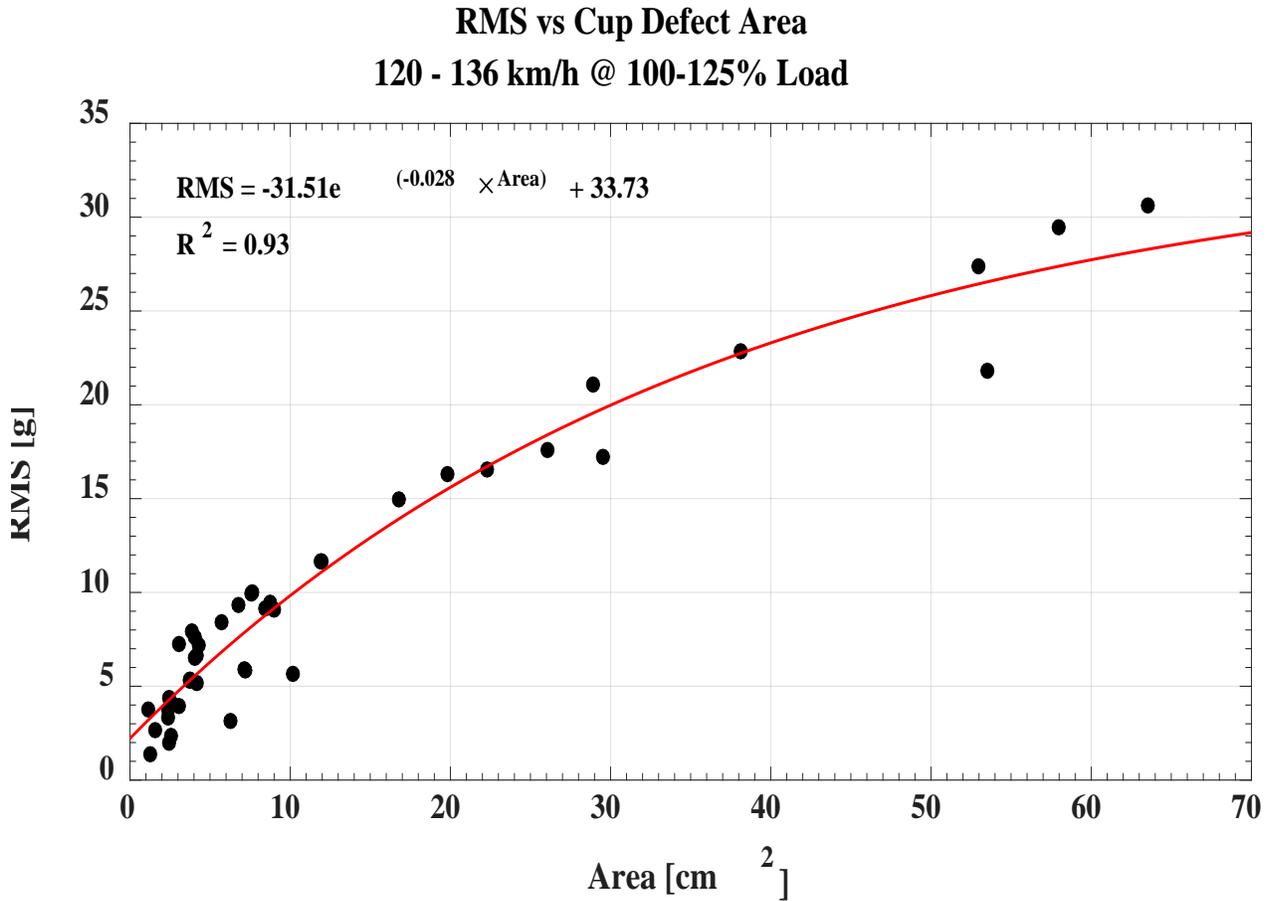
Figure 22. Improved regression analysis of RMS vs cup spall area

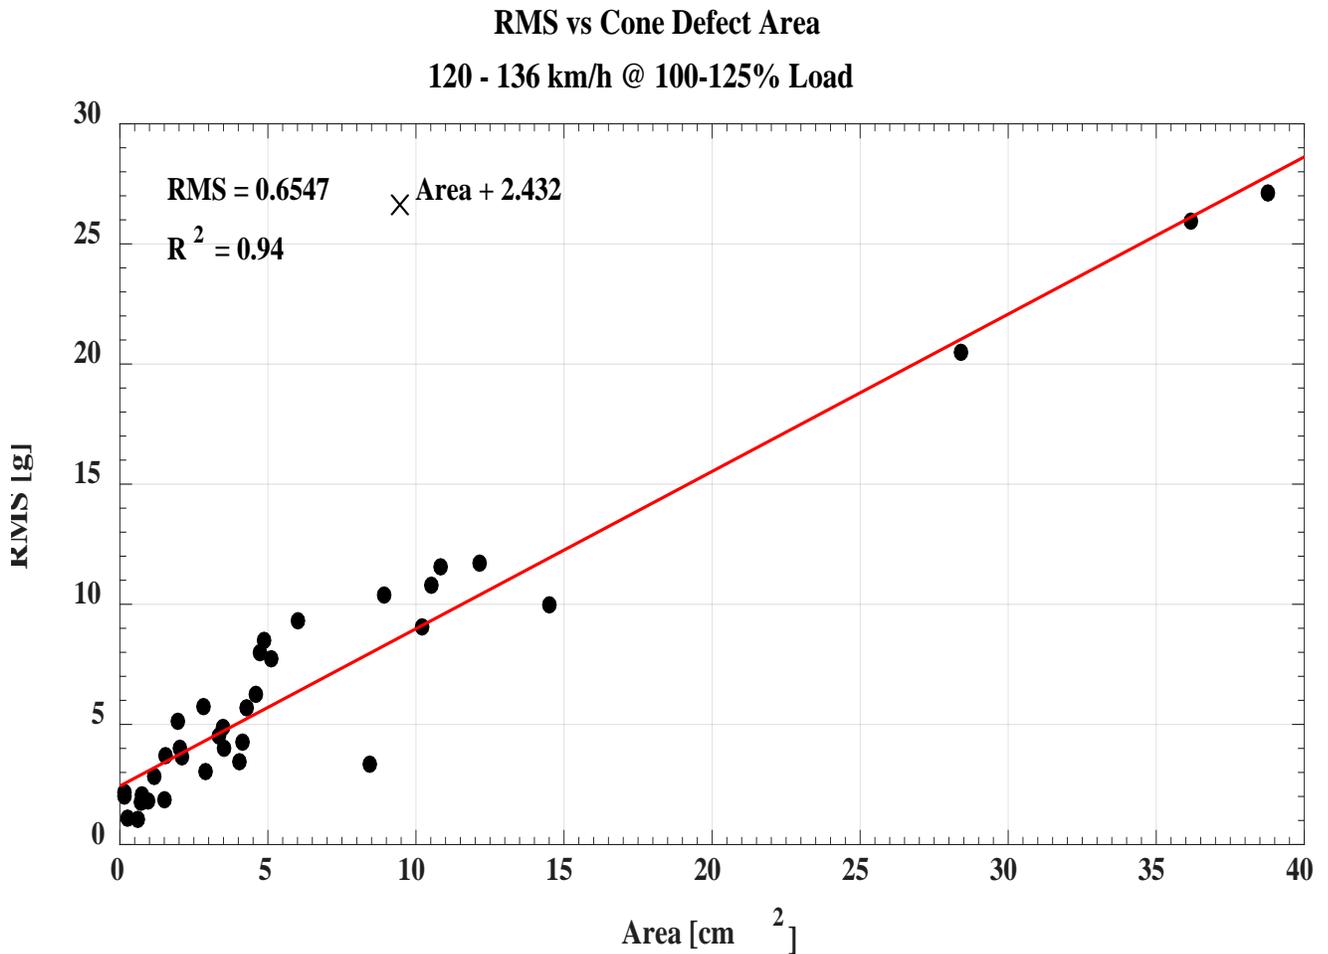
to 0.93. A more significant improvement was observed in the inner ring (cone) correlation, given in Figure 23, which, while retaining its linear form, increased from an R^2 value of 0.74 to and R^2 value of 0.94. While the cup and cone correlations maintained their original trends, the equations were slightly modified to conform with the new data points acquired from the recent laboratory testing.

Figure 23. Improved regression analysis of RMS vs cone spall area

The cup (outer ring) trendlines seen in Figure 28 exhibit natural logarithmic (\ln) behavior due to the exponential function found in the RMS versus defect area regression model. The possible range of growth rates defined by the GR1 and GR2 boundaries is initially limited and increases with the RMS as the exponential trendlines diverge from each other. Since RMS increases as the defect area grows larger (seen in Figure 22 and Figure 23), it is clear that larger defects have a margin of uncertainty in growth rate. Figure 29 presents the GR1 and GR2 trendlines for the cone (inner ring). Note that, unlike the cup trendlines, the upper (GR1) and lower (GR2) growth rate trendlines for the cone exhibit a linear function as is the case for the cone correlations seen in the RMS versus defect area plot (Figure 23).

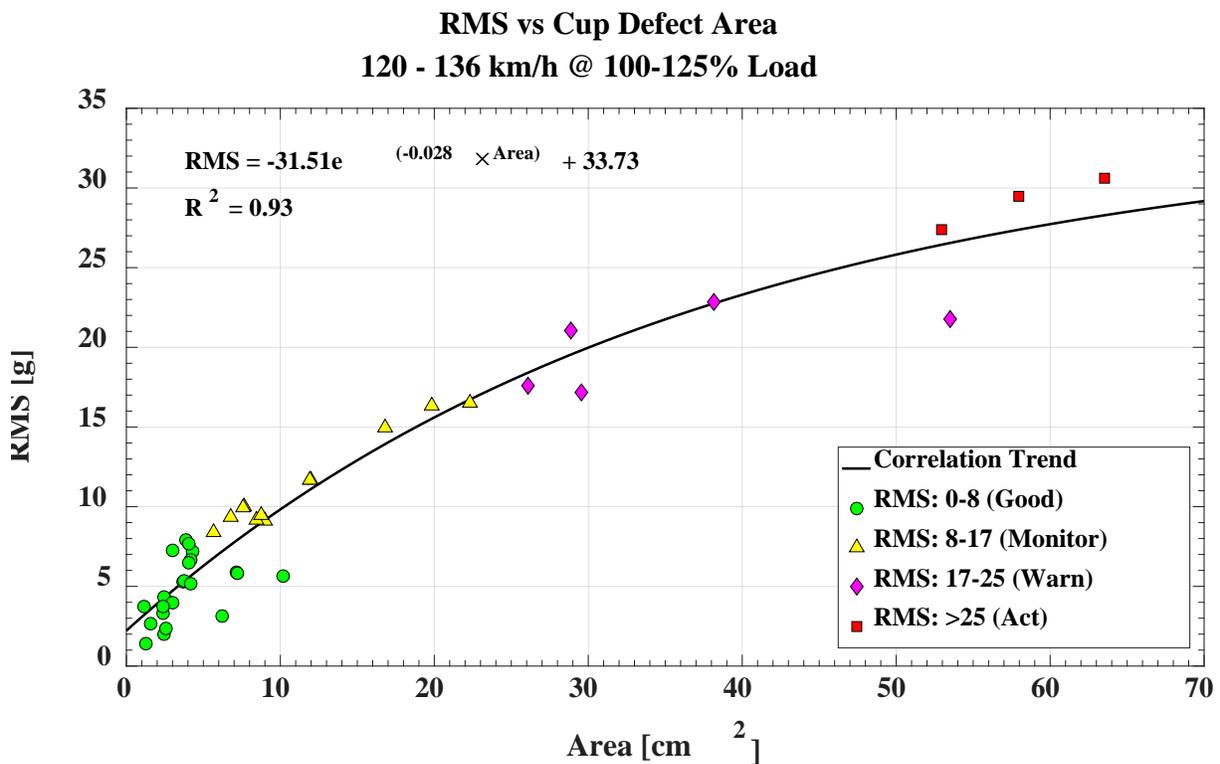
Figure 24. RMS vs cup spall area regression model with condition parameters

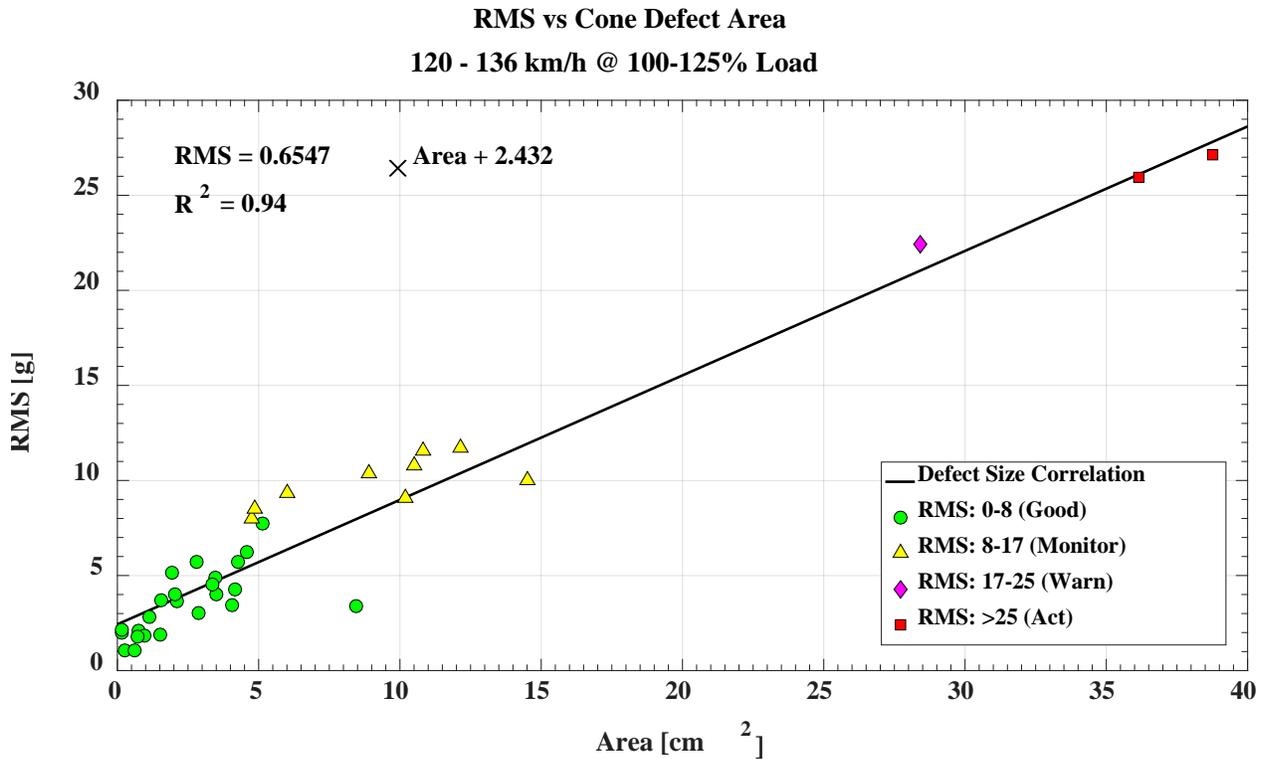
Figure 25. RMS vs cone spall area regression model with condition parameters
