RESIDUAL SERVICE LIFE PROGNOSTIC MODELS
FOR TAPERED ROLLER BEARINGS

A Thesis

MASTER OF SCIENCE IN ENGINEERING

Major Subject: Mechanical Engineering

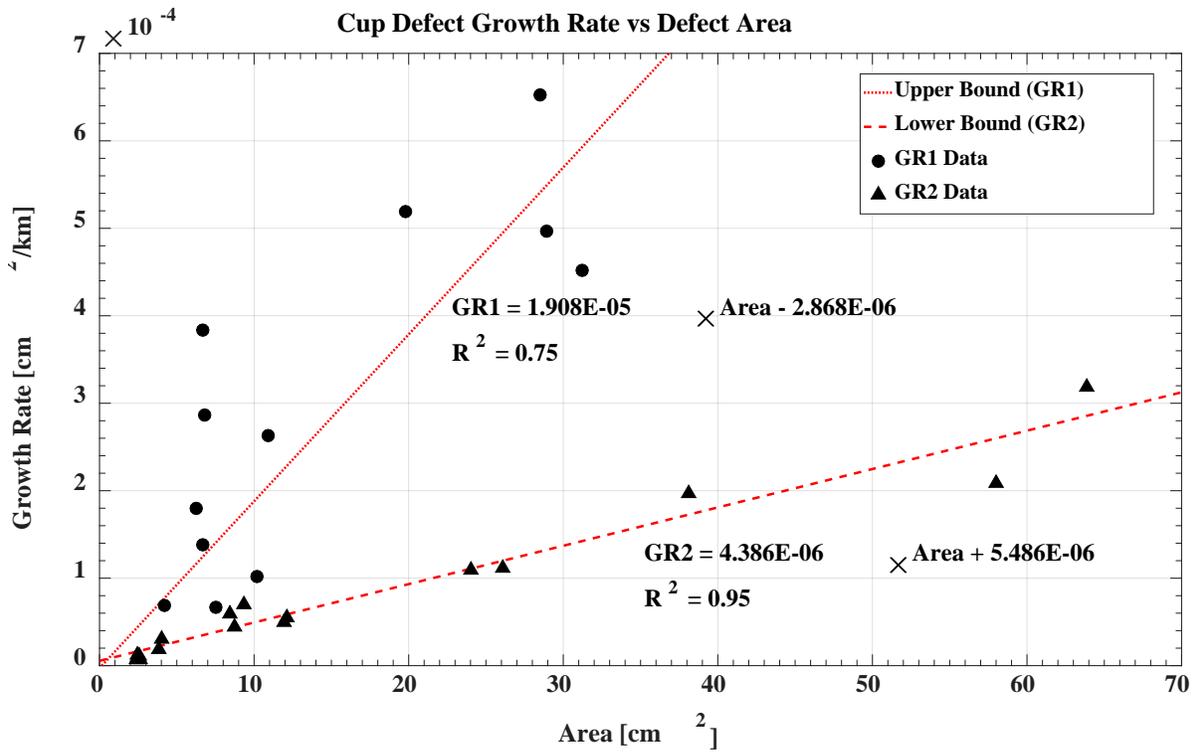
The distance traveled for each experiment was recorded and used to calculate the component spall area growth rate. Figure 26 and Figure 27 shows the area growth rate versus the defect size (area) for cups and cones, respectively. Two trends emerged in both the outer ring (cup) and inner ring (cone) data acquired, namely: an upper bound growth rate correlation (GR1) and a lower bound growth rate correlation (GR2). The reason behind the two distinct growth rate trends is the presence and location of the subsurface inclusions in each raceway. For example, a raceway with several clustered subsurface inclusions near the surface of the raceway will have defects develop at a faster rate as opposed to a raceway with fewer or more dispersed subsurface inclusions. The GR1 equation is used to provide a worst-case scenario for estimating the residual life of a defective bearing assuming the presence of multiple subsurface inclusions. While GR2 is a lower bound equation that provides a baseline growth rate for its respective component.

Figure 26. Cup spall area growth rate versus cup spall area

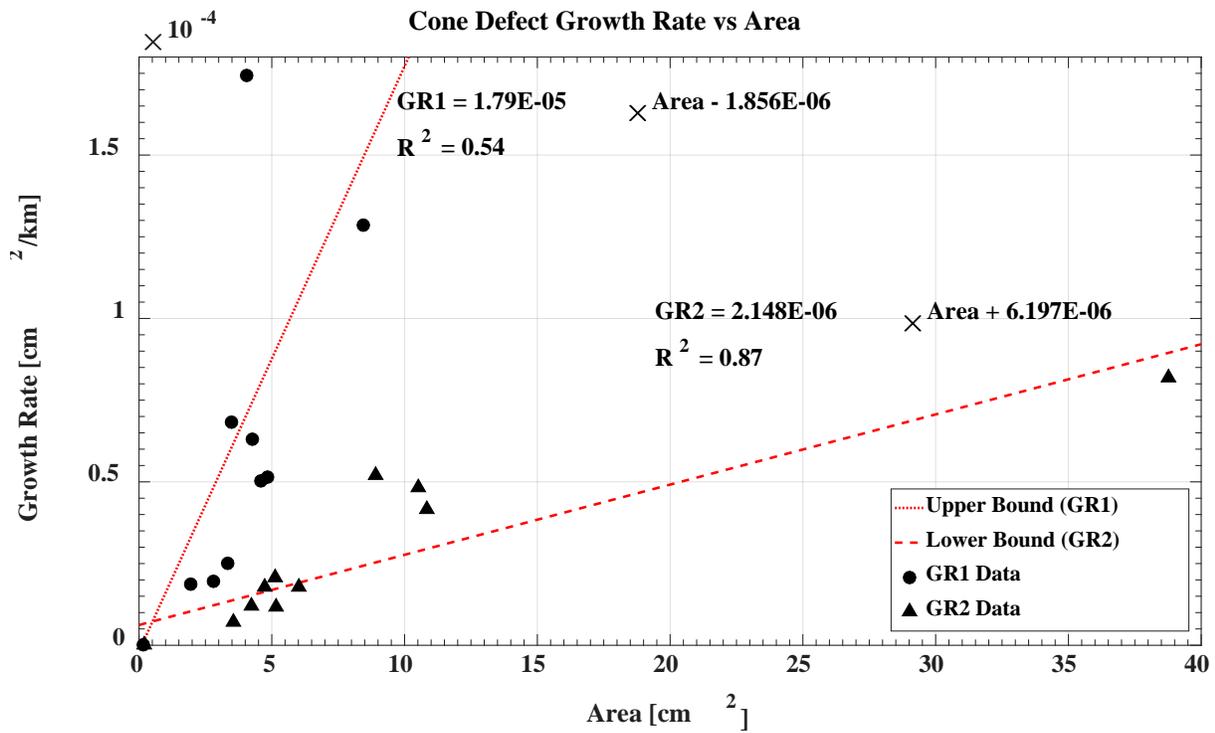
Figure 27. Cone spall area growth rate versus cone spall area

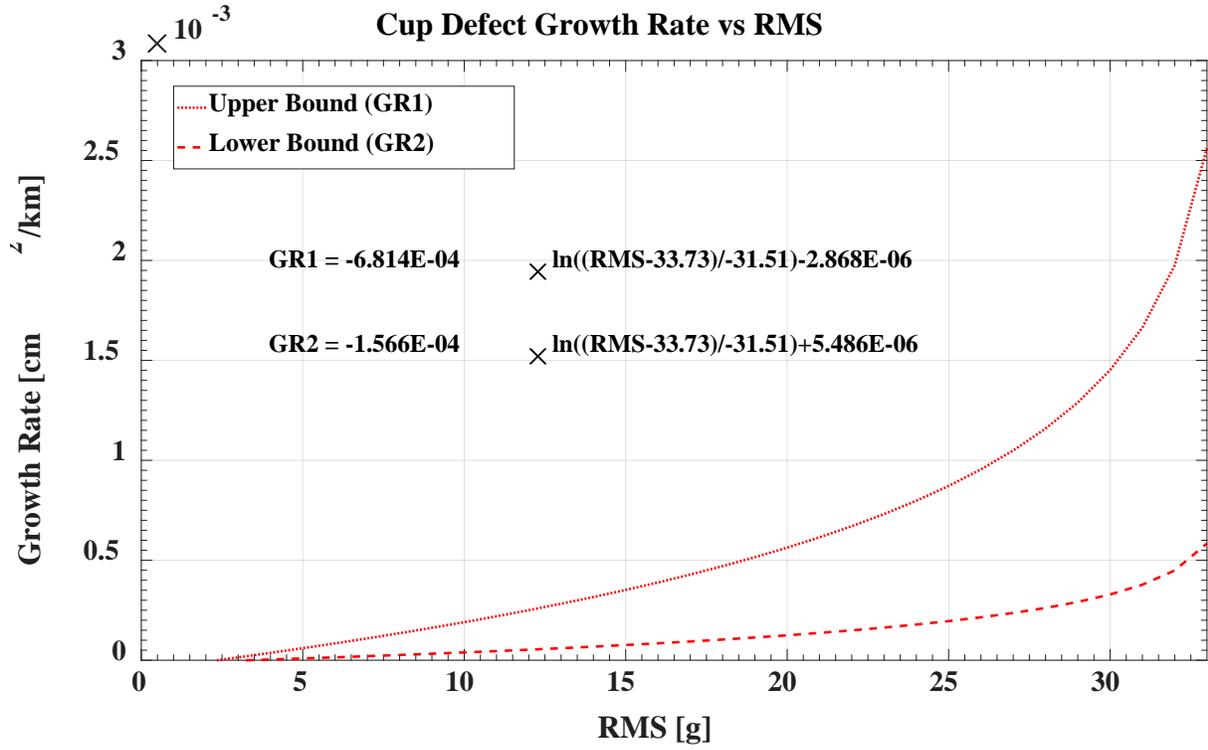
The cup (outer ring) trendlines seen in Figure 28 exhibit natural logarithmic (\ln) behavior due to the exponential function found in the RMS versus defect area regression model. The possible range of growth rates defined by the GR1 and GR2 boundaries is initially limited and increases with the RMS as the exponential trendlines diverge from each other. Since RMS increases as the defect area grows larger (seen in Figure 22 and Figure 23), it is clear that larger defects have a margin of uncertainty in growth rate. Figure 29 presents the GR1 and GR2 trendlines for the cone (inner ring). Note that, unlike the cup trendlines, the upper (GR1) and lower (GR2) growth rate trendlines for the cone exhibit a linear function as is the case for the cone correlations seen in the RMS versus defect area plot (Figure 23).

Figure 28. Cup spall area growth rate versus RMS

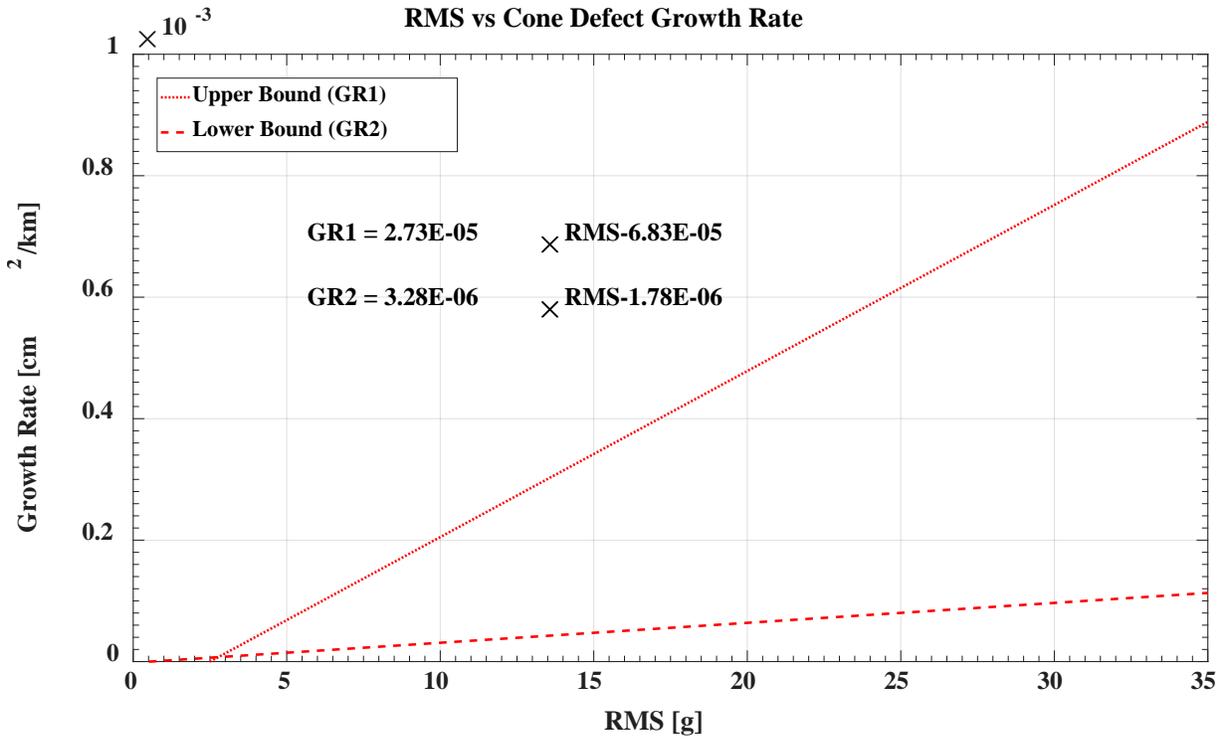
Figure 29. Cone spall area growth rate versus RMS

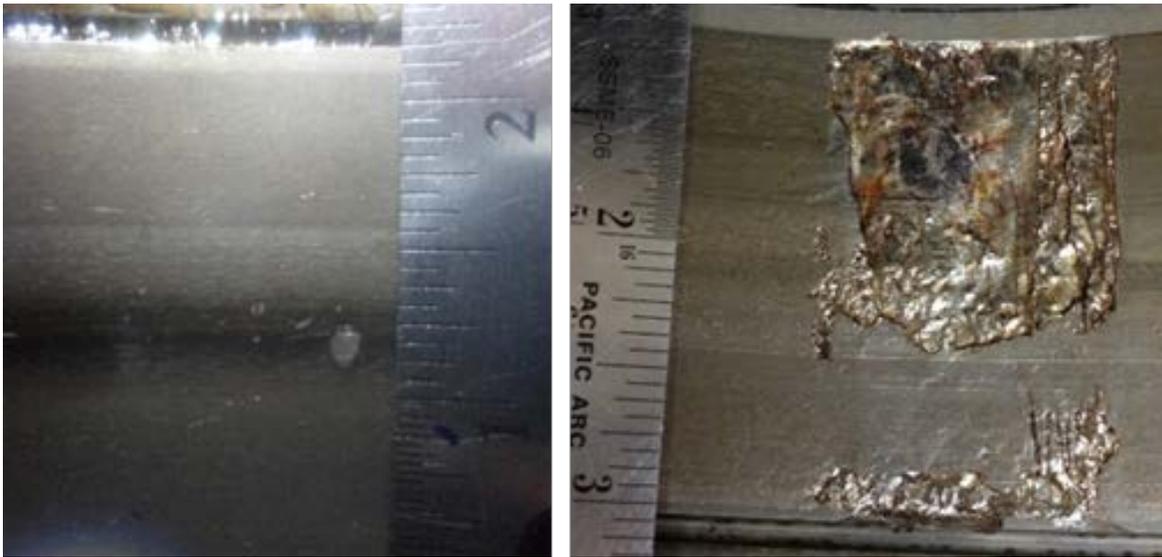
Experiment 200 featured an outer ring (cup) with an initially pitted inboard raceway, shown in Figure 30(left). The cup ran on the four-bearing tester (4BT), placing the pitted area in the maximum load position to simulate a worst-case scenario. The experiment ran a total of 81,600 km (50,700 miles) during which the pitted raceway developed a spall with an area of 9 cm² (1.4 in²), pictured in Figure 30 (right). The resulting defect area corresponds to approximately 2.5% of the total area (367 cm²) of a class K or class F outer ring raceway.

Figure 30. Experiment 200: Initial cup raceway (left) and final cup raceway (right)

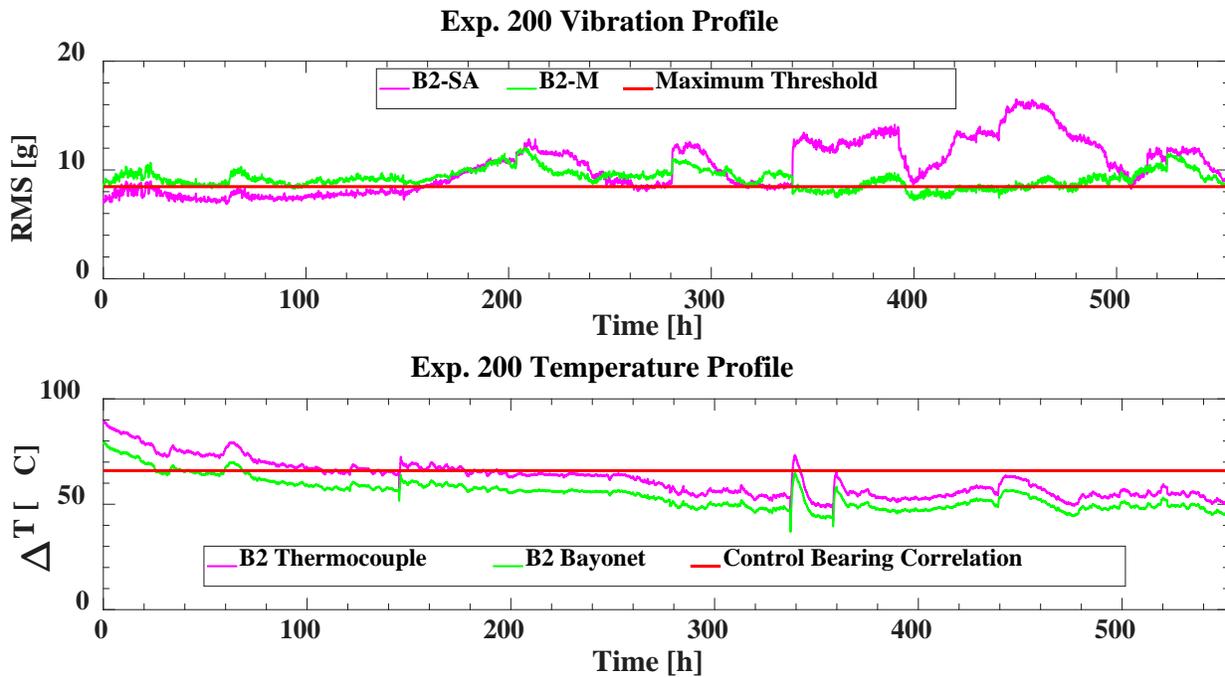
Figure 31. Vibration and temperature profiles for Experiment 200

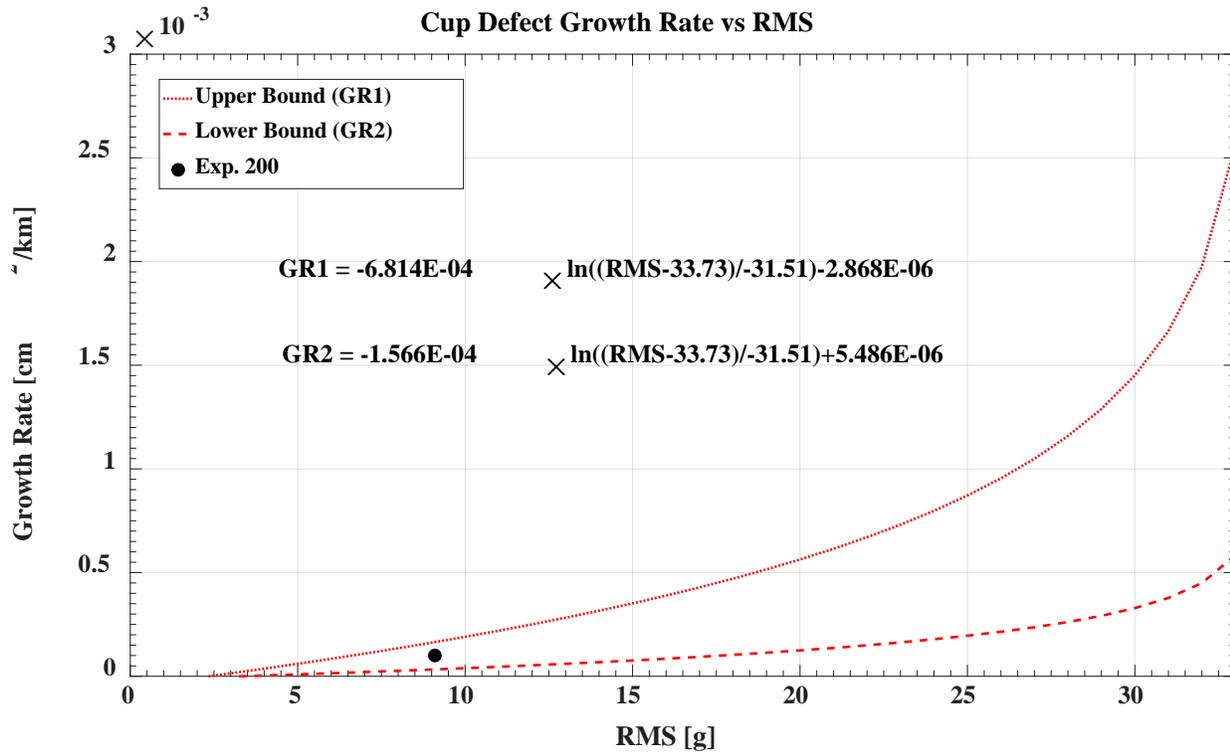
Averaging the last two hours of the SA accelerometer, an RMS of 9 g was found. The RMS was used to calculate a theoretical defect area using the equation found in the outer ring RMS versus defect area regression analysis (Figure 24). The calculated defect area of 8.8 cm², listed in Table 6, is 98% of the actual area (i.e., a 2% error). The RMS value was also used to calculate the upper and lower growth rate boundaries for the defective outer ring. Using the GR1 and GR2 equations from the growth rate versus RMS plot the upper and lower bounds yielded values of 1.7E-04 cm²/km and 0.4E-04cm²/km, respectively. The actual growth rate, as measured during the visual inspection, was 1.0E-04cm²/km which falls well within the range provided by the regression analysis, as can be observed in Figure 32.

Figure 32. Experiment 200 cup spall growth rate in relation to the developed regression model

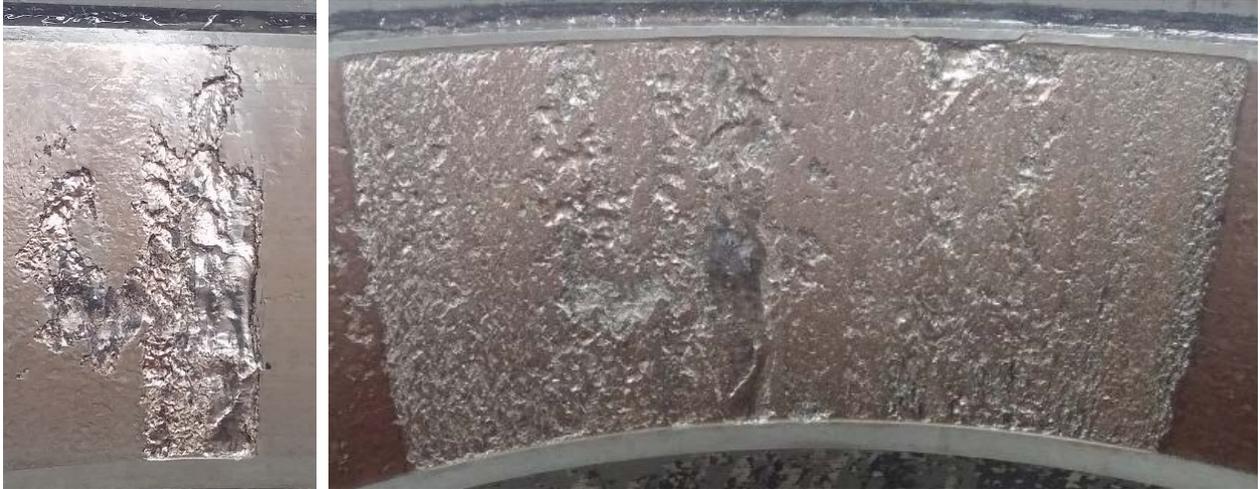
An outer ring (cup) with an initial inboard spall area of 24 cm² (3.7 in²), which had a previous RMS vibration value of 16 g (monitor condition/yellow indication), was placed in the B3 location (refer to Figure 11) of the four-bearing tester (4BT) for further defect propagation. Like Experiment 200, Experiment 184B had the defect location positioned directly in the region of maximum applied load. After running a simulated distance traveled of 47,000 km (29,000 mi) at full speed and full load conditions, the defect area grew to a size of 53 cm² (8.2 in²), as depicted in Figure 33 (right). The post experiment defect warranted a red indication (act condition) due to its vibration signature giving an RMS of 27 g while encompassing 14% of one outer ring raceway area (367 cm²).

Figure 33. Experiment 184B: Initial cup raceway (left) and final cup raceway (right)

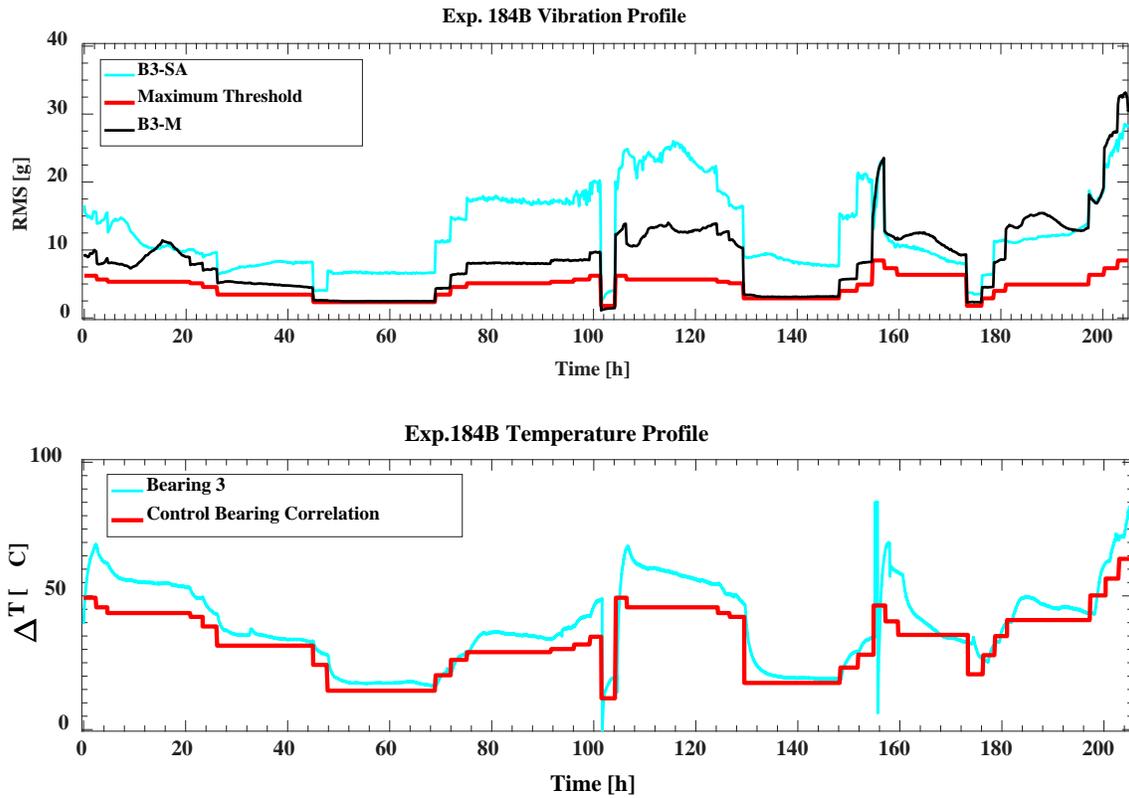
Figure 34. Vibration and temperature profiles for Experiment 184B

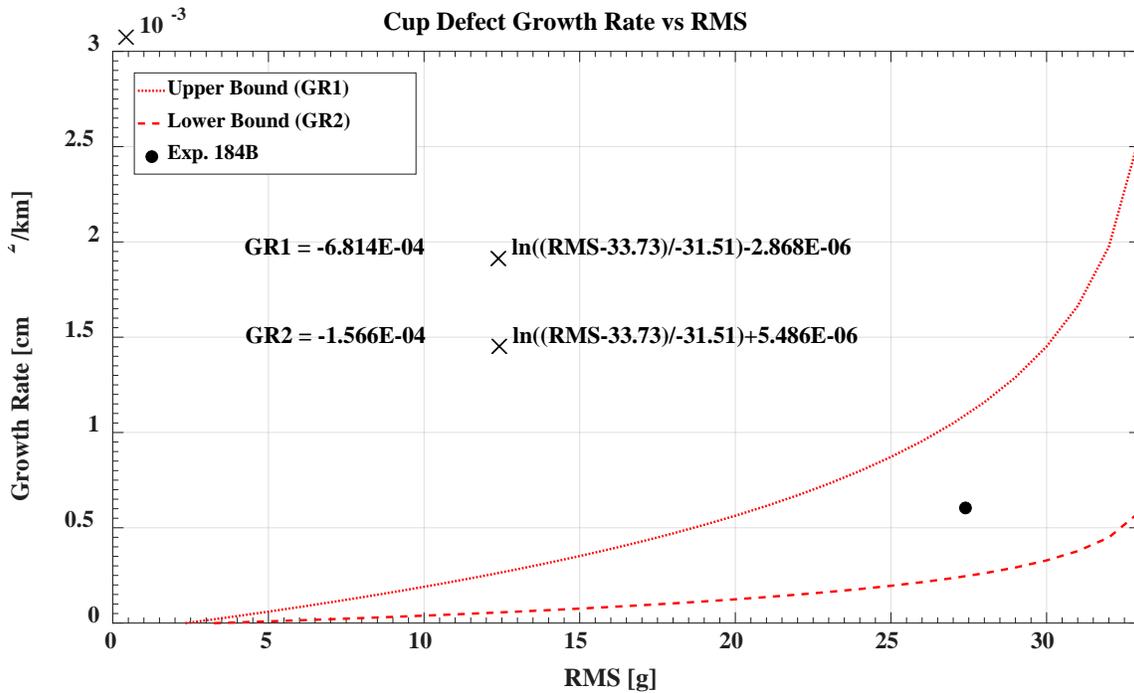
Figure 35. Experiment 184B cup spall growth rate in relation to the developed regression model

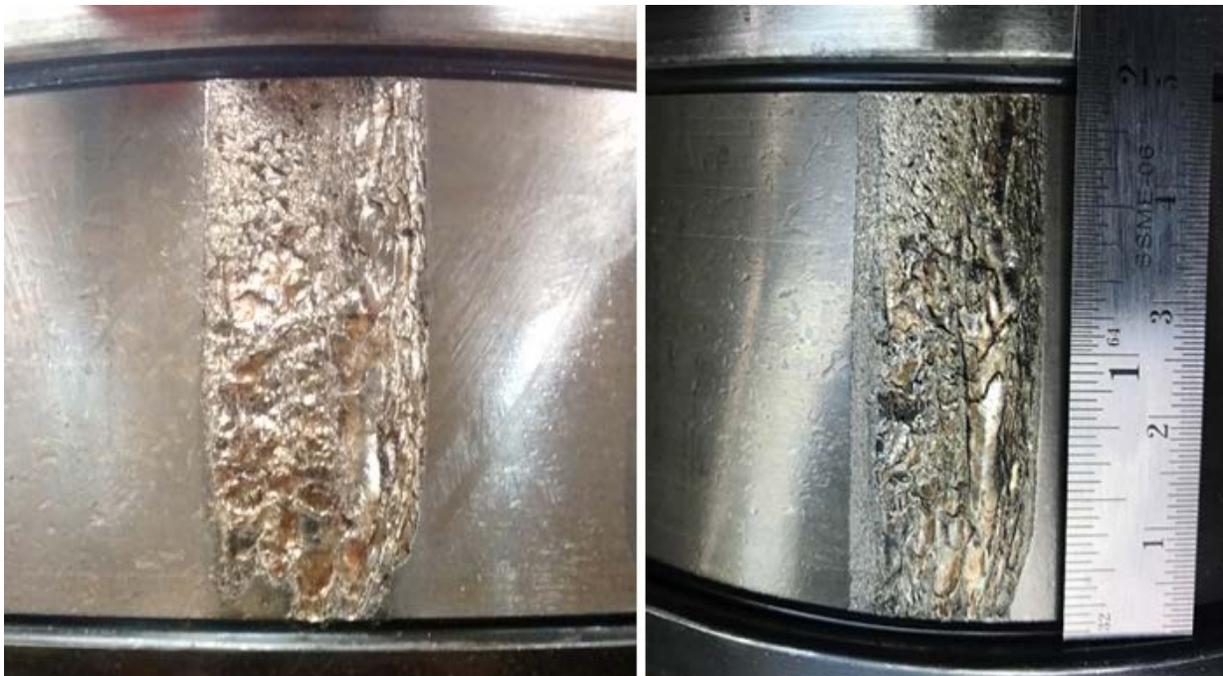
In Experiment 202A, a defective cone with an initial spall area of 9 cm^2 (1.4 in^2) was placed in the single-bearing tester (SBT) for further defect propagation. The experiment ran under full-speed (137 km/h) and full load conditions (100% load) for a total of 33,000 km (20,500 mi) during which the spall size grew to 10.5 cm^2 (1.6 in^2). Figure 37 shows the vibration (top) and temperature (bottom) profiles for the duration of this experiment.

Figure 36. Experiment 202A: Initial cone raceway (left) and final cone raceway (right)

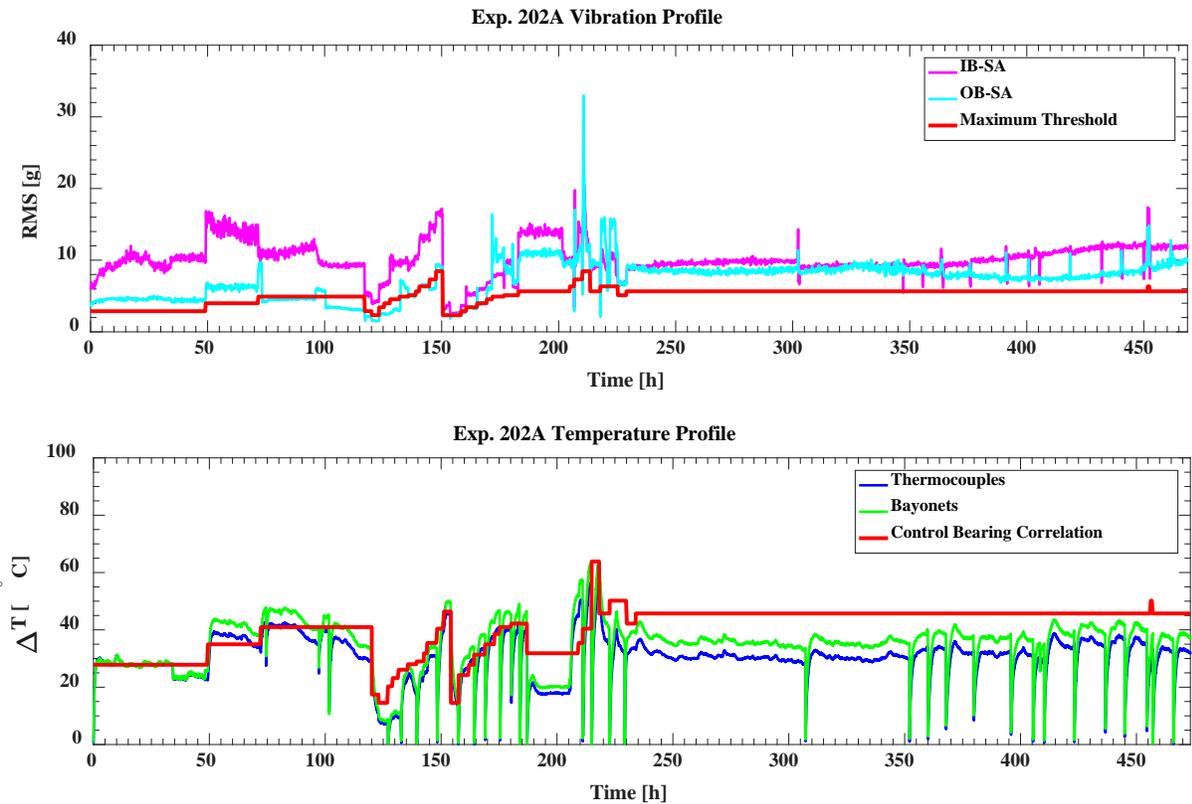
Figure 37. Vibration and temperature profiles for Experiment 202A

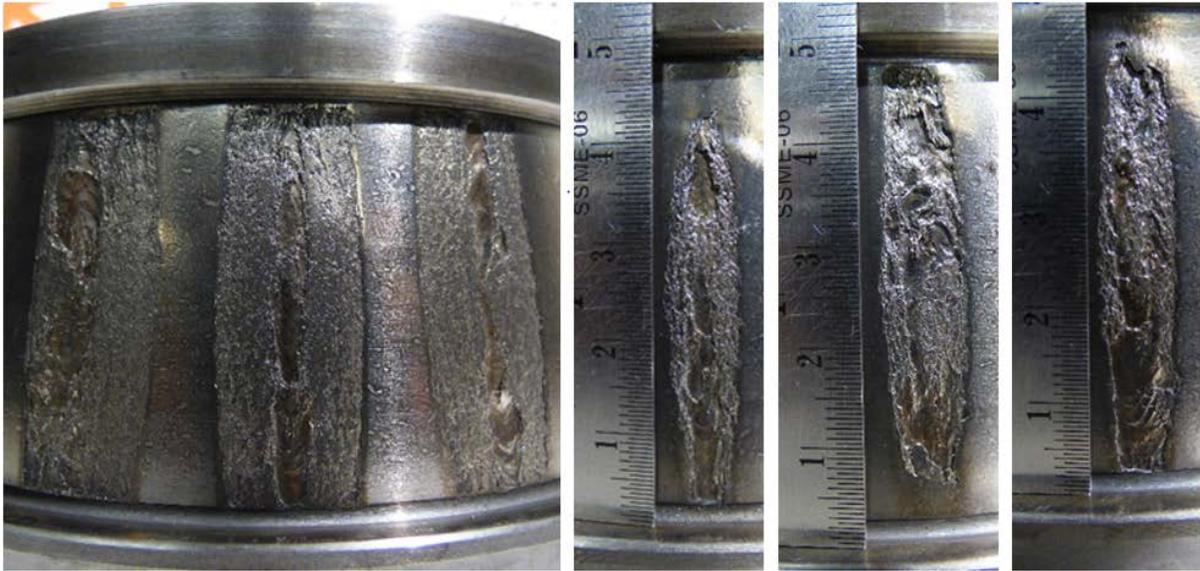
Figure 39. Experiment 206 initial cone raceway (multiple spalls)

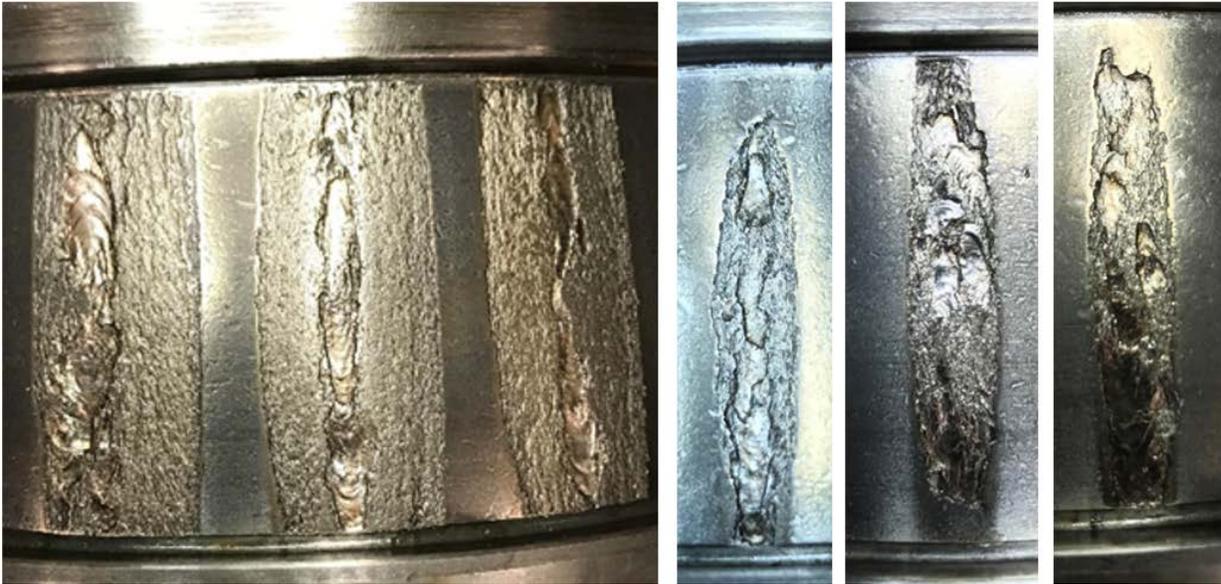
Experiment 206 operated at full speed and full load conditions on the SBT for a simulated distance traveled of 14,000 km (9,000 mi) in which the spall area increased to 39 cm^2 (6 in^2), as shown in Figure 40. The experiment was stopped, and the bearing was disassembled and visually inspected once the vibration signatures indicated further propagation of the spall had occurred. Propagation patterns can be observed in Figure 41 (top) starting from experiment hour 100.

Figure 40. Experiment 206 final cone raceway

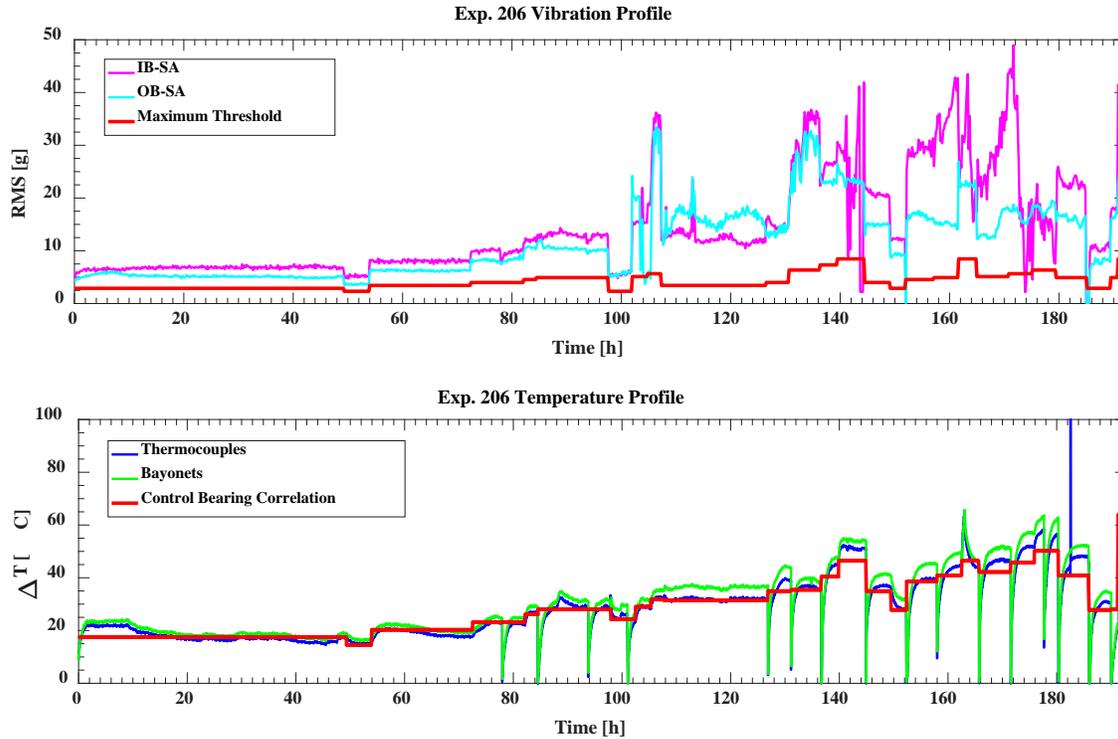
Figure 41. Vibration and temperature profiles for Experiment 206

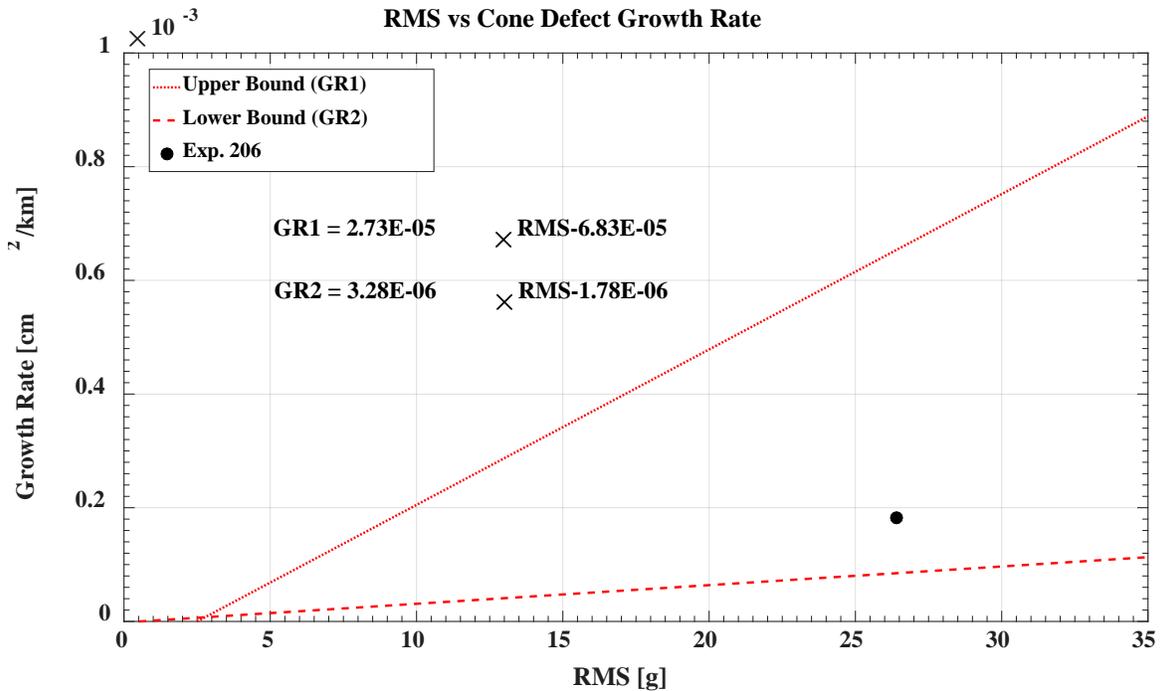
Figure 42. Experiment 206 cone spall growth rate in relation to the developed regression model
